Upper Suspension Balljoints in early Ford Falcons and Fairlanes

Ford Falcon balljoint problem discovered:

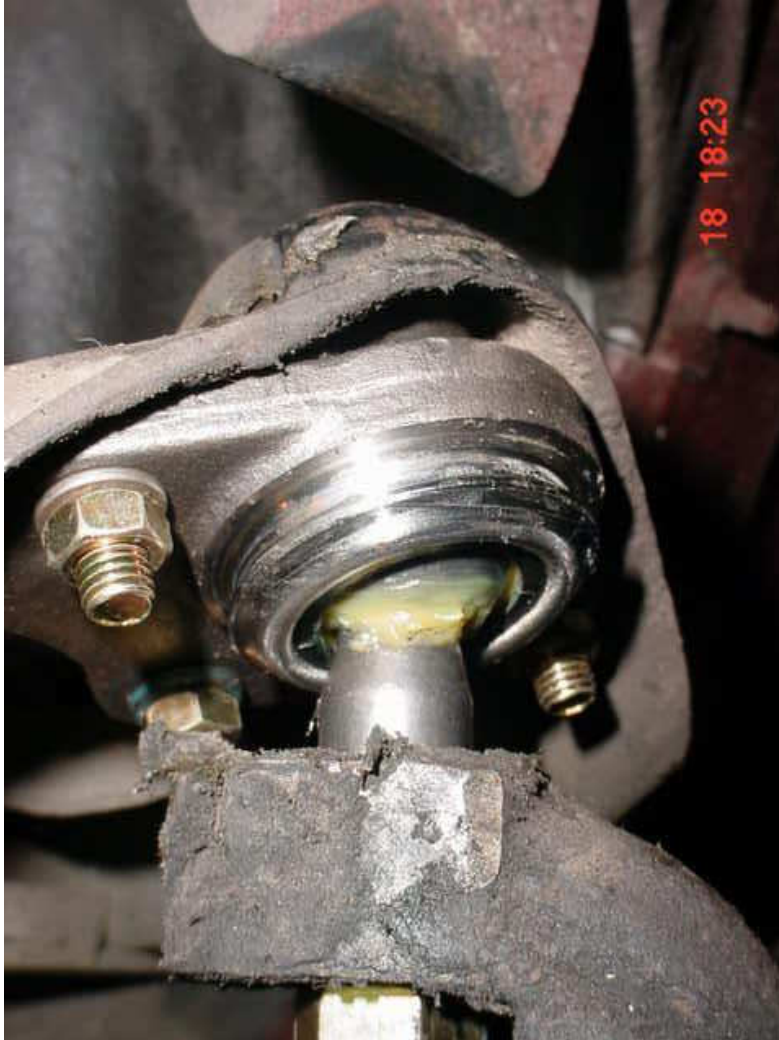
This photo of a 3-bolt 'WJ Automotive' balljoint shows the balljoint having reached its limit of angular movement with about 25mm of suspension travel still remaining before the bump-stop would be reached.

When the balljoint 'binds' like this but is forced to travel further, very high loadings occur. The following photo shows the result, as the edge of the balljoint housing causes damage to the shaft while trying to break it.

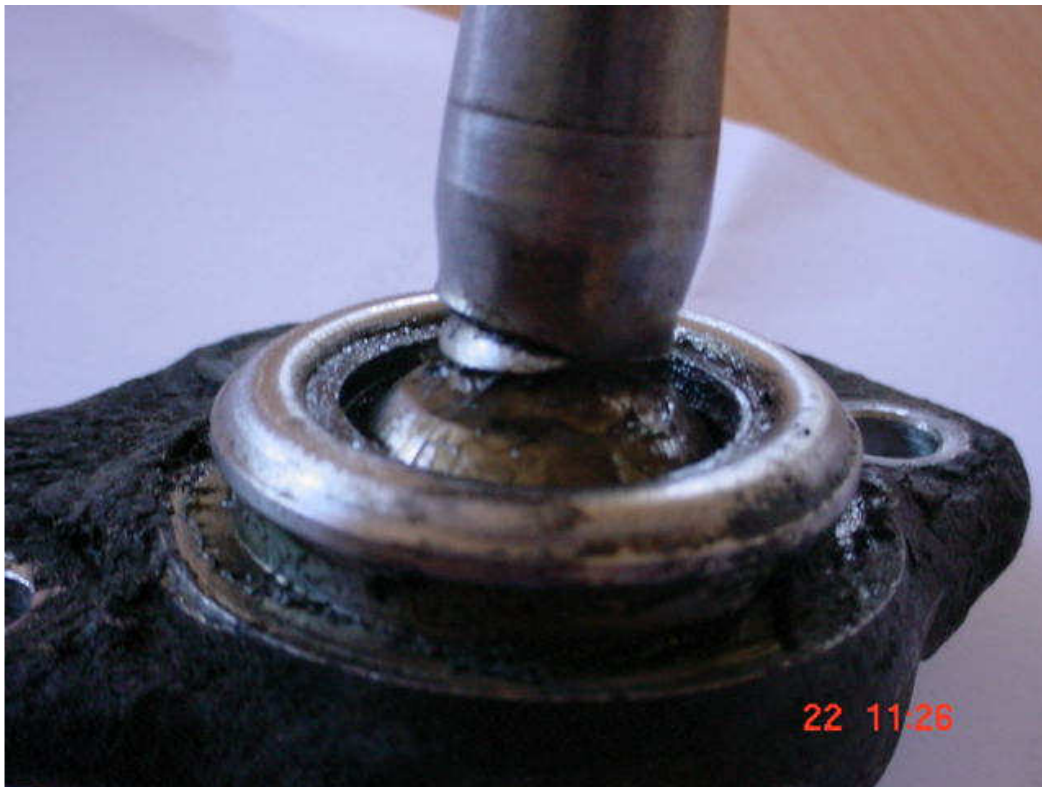
The deep groove in the 'Camelot' brand balljoint shaft has been caused by the high loads.

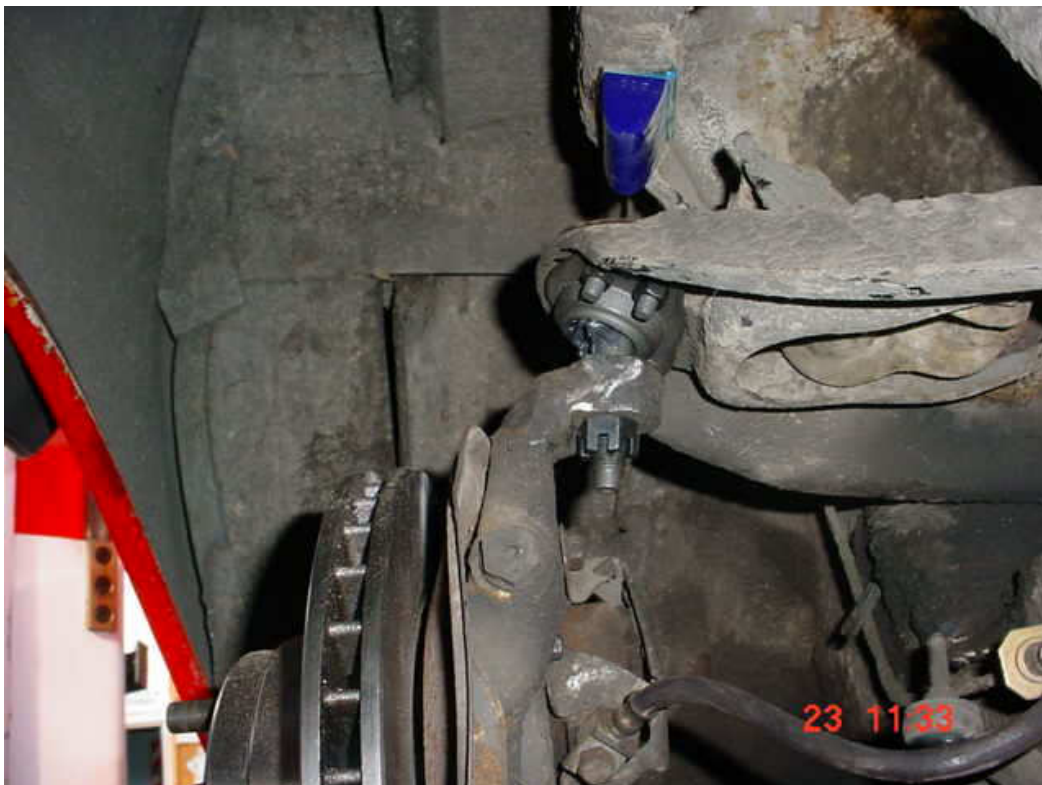
This picture of an XY Falcon with the 4-bolt 'WJ Automotive' balljoint is at the limit of suspension travel due to the balljoint reaching its maximum angular movement. About 25 mm more suspension travel is required to contact the bump-stop.

LVV Certifiers that are certifying Ford Falcons or Fairlanes for any reason need to check the balljoints to identify the brand and condition. The proper means of assessing whether or not the balljoint is safe is by removal of the springs, and moving the suspension throughout its complete range of travel between the rubber bump stops, checking that the bumpstops are reached before

the balljoint binds against its housing. Obviously this takes time, and you should alert any potential owner that this situation may exist, and offer them the opportunity to have you carry out the inspection for them, at an additional charge for your time.
