Helping New Zealanders Build & Modify Safe Vehicles

### Aftermarket Tubular Suspension Arms with Cantilever-style Ball Joints

This Information Sheet is released in conjunction with LVVTA Safety Alert #02-2023, and explains the issues with aftermarket upper and lower suspension arms made by various American companies, which feature poor designs, and in some cases poor workmanship. These companies include Ridetech, Chris Alston's Chassis Works/KP Components, and Porterbuilt/PBFab - however there may be others we are not yet aware of. LVVTA is concerned for the safety of road users and occupants of vehicles fitted with these potentially unsafe arms.

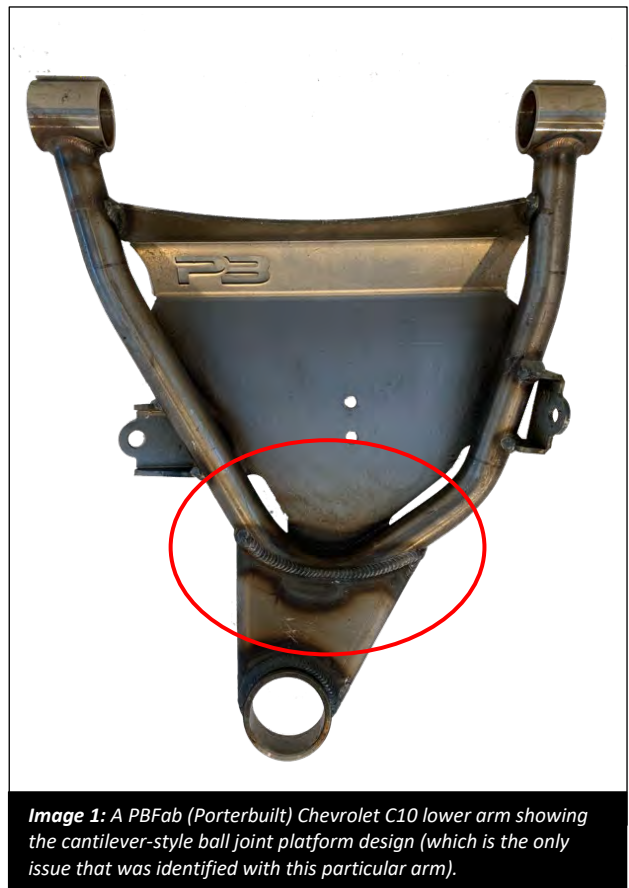
*Image 1: A PBFab (Porterbuilt) Chevrolet C10 lower arm showing the cantilever-style ball joint platform design (which is the only issue that was identified with this particular arm).*

The most common problem relates to the ball joint platform, which is welded onto the outer part of the U-shaped arm section, creating a large cantilever. There are also no gussets to support the critical function welds at this highly loaded point - in many cases carrying the vehicle's entire corner weight. This results in extremely high load concentrations at the ends of the welds, which is considered to be poor engineering practice.

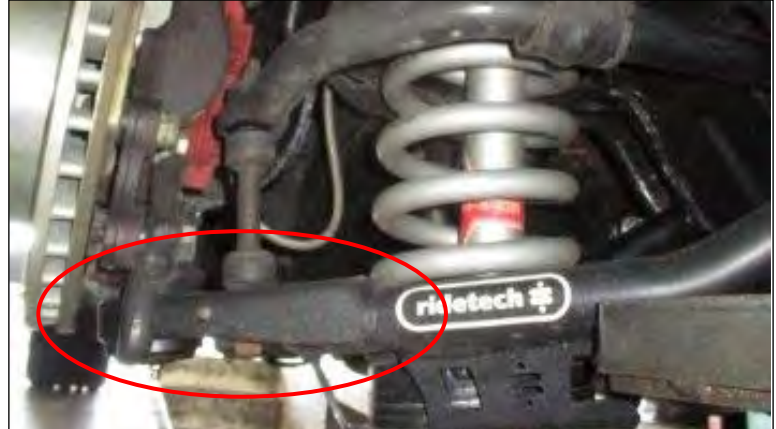
In some cases this poor design has been found to occur in conjunction with substandard welding, which increases the risk of a catastrophic failure.

*Image 2: This is an example of a Ridetech Chevrolet C10 truck lower arm with cantilever-style ball joint design.*

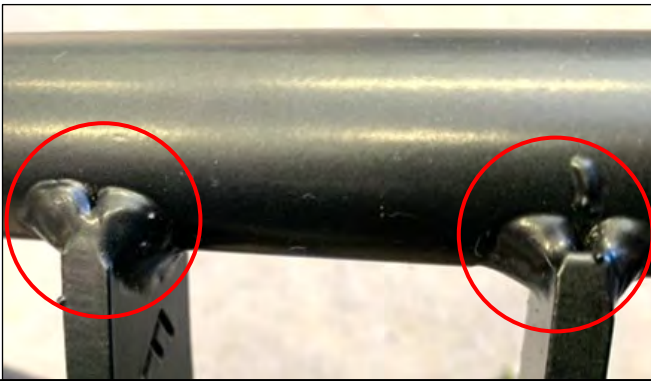
To make matters worse, some examples of the arms inspected by LVVTA have had significant weld defects (including undercut, craters, and incomplete welds), all of which can significantly reduce the strength of the welded connections and increase the risk of a catastrophic failure or fatigue-related issues, such as cracking. Many of the weld defects were at the most highly loaded connection points.

*Image 3: This is an example of incomplete welds on the coil-over mounts.*

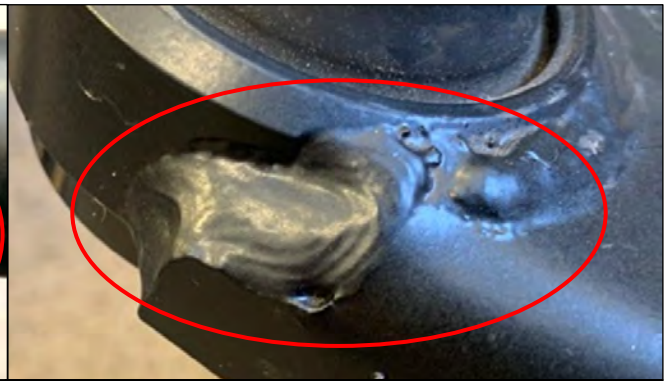
*Image 4: This is an example of a poor weld including craters and incomplete welds at the ball joint end housing.*

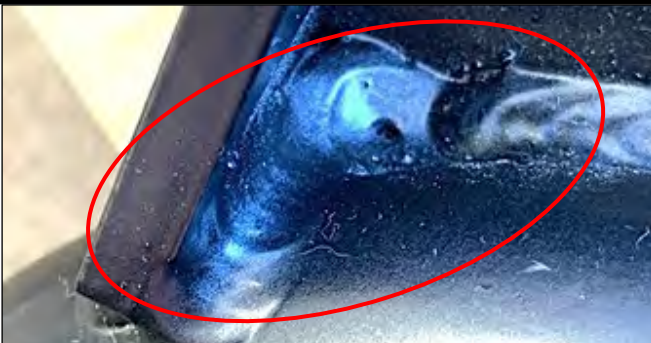
*Image 5: This is an example of an incomplete weld and craters, at the ball joint end housing (a highly loaded part of the arm).*

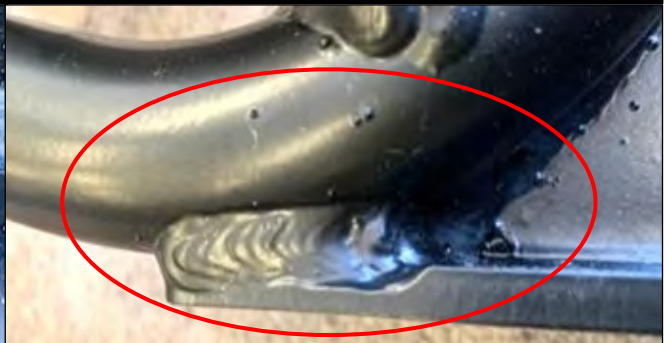
*Image 6: This is an example of a weld at the ball joint end housing (a highly loaded part of the arm) which has significant undercut, a weld defect that reduces the thickness and strength of the parent material.*

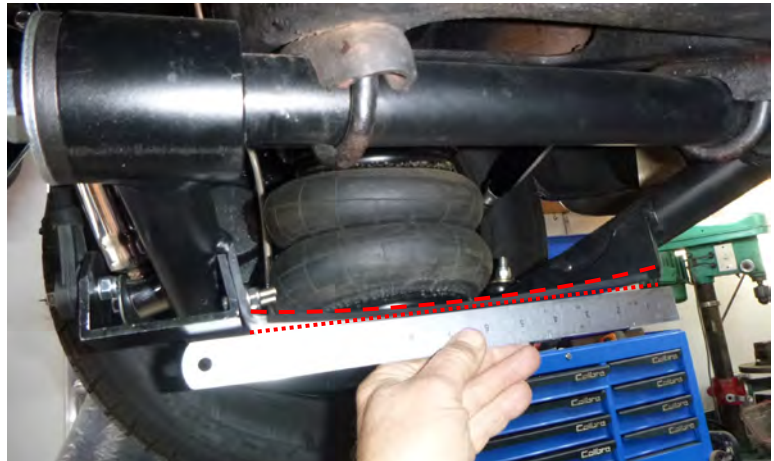
Loads on suspension components are significantly higher when a vehicle is in motion, especially in the case of loaded suspension components (where they are required to carry the weight of the vehicle), for example, a lower control arm that has the spring attached to it. In this case, an arm was found to have bending visible to the naked eye when the vehicle's weight was applied to the arms (such as when the vehicle is on a hoist and lowered onto the ground). In real terms, the actual loads on a component could be up to three times the weight of the vehicle (referred to as 3G, or 3 times gravity), when combinations of loads occur, for example hitting a large pot-hole at speed, on a corner, while braking. Automotive suspension components should also be designed to include a safety factor of 1.5. This means a suspension arm should be designed to withstand four and a half times the actual weight of that corner of the vehicle, or 4.5G (4.5 times gravity).

*Image 7: This is an example of a Chevrolet C10 truck Ridetech lower control arm, with a visible bend or sag in the air bag mounting platform.*

Where part of an arm exhibits visible bending while the vehicle is stationary, bending will become worse when the vehicle is being driven. This raises significant concerns about the long-term strength and durability of these arms as fatigue-related issues will almost certainly become apparent in time.

*Image 8 and 9: This is the Ridetech lower control arm shown in Image 7 after significant rectification work to reinforce the ball joint bracket, and eliminate the sagging in the air bag mounting plate. LVVTA thanks Custom Street Rides (CSR) for their assistance with developing and testing this rectification.*
