## Total Cost Involved (TCI) Independent Front Suspension System Failure

*The purpose of this LVVTA Information Sheet is to advise LVV certifiers and potentially-affected vehicle owners, suppliers, and distributors of a safety risk associated with a range of Total Cost Involved (TCI) independent front suspension (IFS) systems.*

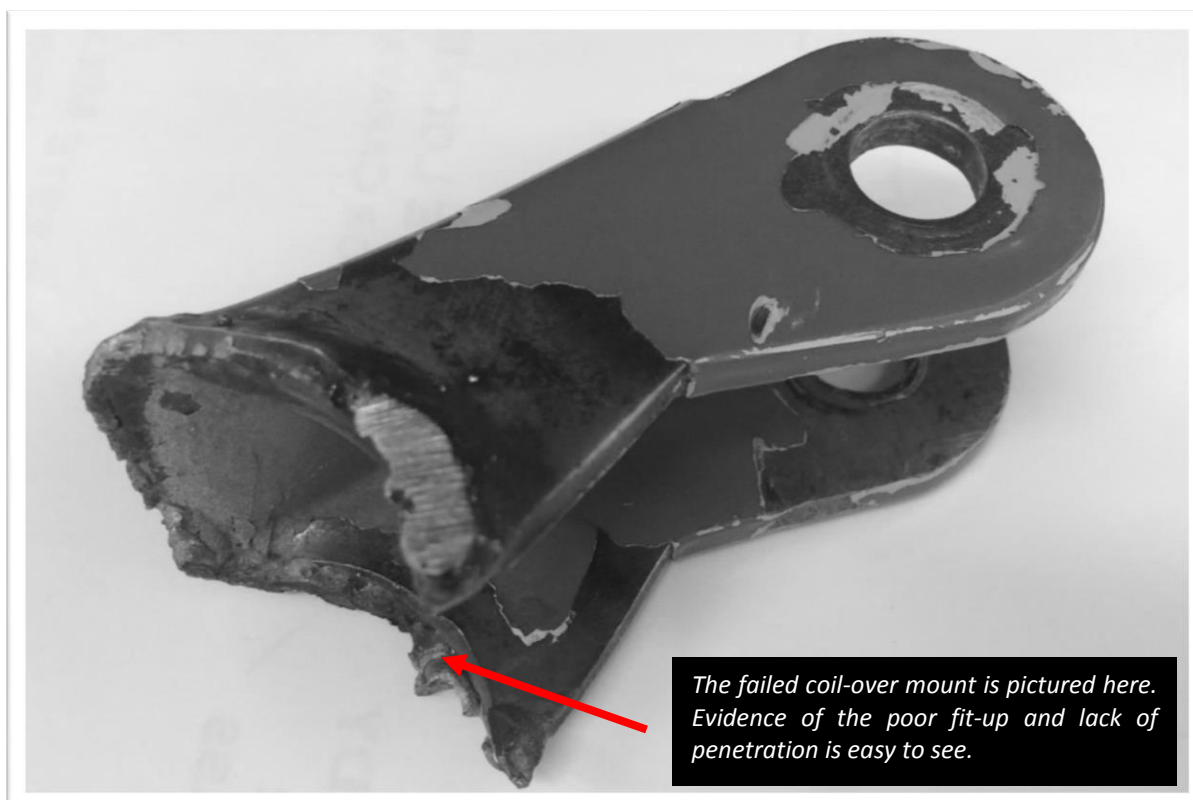
TAC members are of the opinion that with only (approximately) 90 mm of weld area in total, the design of the coil-over mounting bracket does not allow sufficient weld area to provide an adequate safety factor. Additionally, the highest loads are applied to the very end of the weld, at the edge of the bracket. That means the main load-bearing welds (on each side of the bracket) are only around 60 mm in total.

To achieve an increase in weld area, the bracket should extend further down the outside of the 'beam', which has the added advantage of adding material and weld area in tension; — the direction of highest loading. There are numerous other ways that weld area can also be achieved whilst maintaining aesthetic appearances. TAC members have recommended to TCI that the bracket is redesigned to provide an increased safety factor.

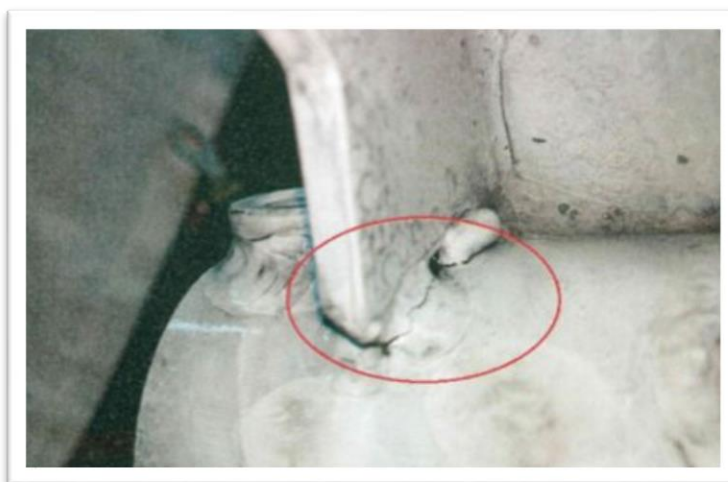
If *any* visible cracking or other significant weld defects are evident, the vehicle owner must be advised that rectification work is required, and they should not continue to operate the vehicle until such time as the rectifications have taken place.
