## Total Cost Involved (TCI) Independent Front Suspension System Failure

*The purpose of this LVVTA Information Sheet is to advise LVV certifiers and potentially-affected vehicle owners, suppliers, and distributors of a safety risk associated with a range of Total Cost Involved (TCI) independent front suspension (IFS) systems.*

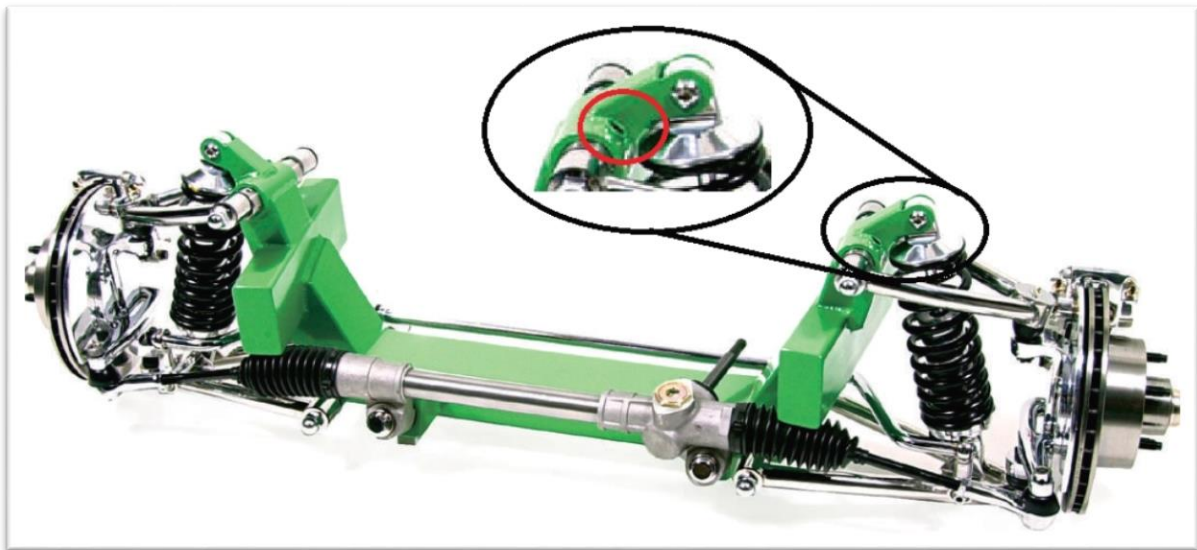
During 2017 there was a catastrophic failure of a welded upper coil-over shock absorber mount on a newly installed and LVV certified TCI IFS. That failure directly resulted in a serious motor vehicle accident due to the complete collapse of one side of the front suspension, and the integral bump-stop which also became disconnected as a result of the failure. Fortunately, no-one was injured.

TCI make several styles of IFS. The design which is affected is the coil-over IFS which has an upper coil-over mount welded to the upper a-arm pivot tube, as shown — along with the area of failure — below. A similar design is offered by TCI for a variety of IFS systems which utilise coil-over shocks.

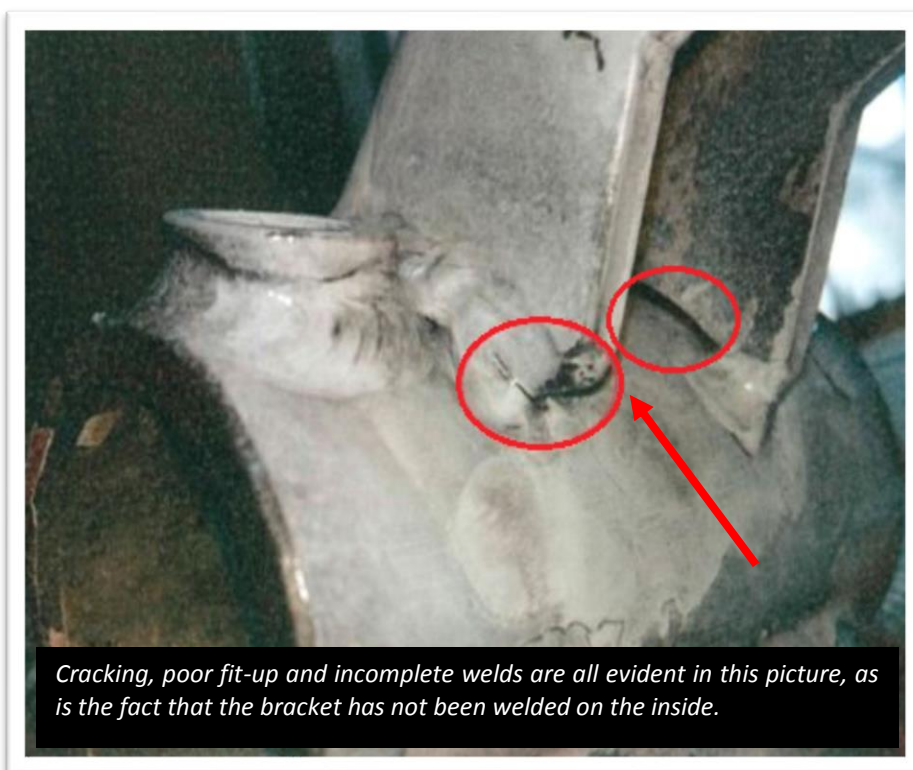
- the throat thickness of the weld is insufficient; and
- the weld is concave, not convex, which results in a reduction in weld strength; and
- it appears that the angle of the welding tip had been aimed more toward the coil-over mounting bracket, and not the pivot tube. The bracket — which was made from thinner material than the tube — received the bulk of the heat, which had the effect of providing insufficient penetration of the weld to the much thicker pivot tube. Being thicker material, the pivot tube should have received a higher proportion of the heat to enable correct fusion, but in fact the opposite occurred.

The resultant weld was not sufficiently strong to support the weight and bump-loads of the corner of the vehicle, and the coil-over mounting bracket tore away in three stages, twisting and distorting the bracket as it broke away from the beam.

The coil-over mounting bracket was poorly fitted-up to the tube prior to welding, which left a gap of up to 3 mm between the underside of the bracket and the tube to which it is welded.

This resulted in a lack of fusion, and in the weld essentially becoming a 'bridge' between the two parts, which provided inadequate strength.

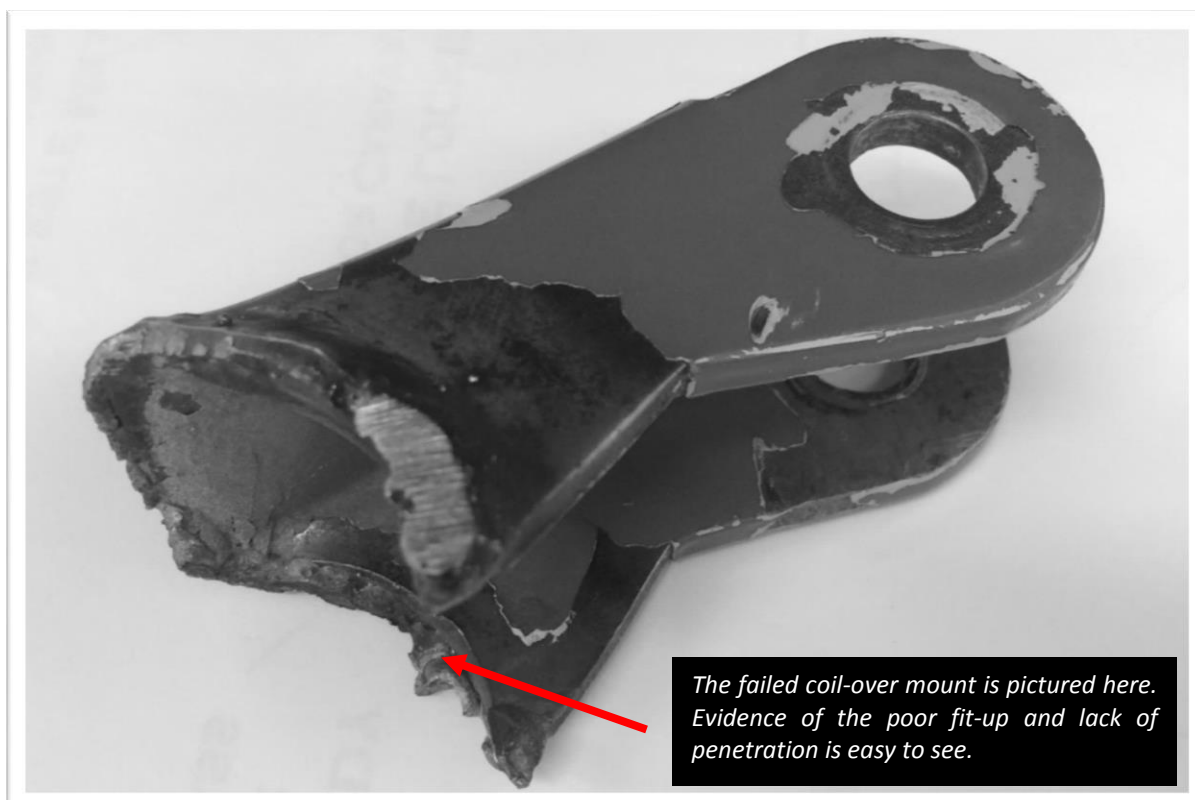
TAC members are of the opinion that with only (approximately) 90 mm of weld area in total, the design of the coil-over mounting bracket does not allow sufficient weld area to provide an adequate safety factor. Additionally, the highest loads are applied to the very end of the weld, at the edge of the bracket. That means the main load-bearing welds (on each side of the bracket) are only around 60 mm in total.

To achieve an increase in weld area, the bracket should extend further down the outside of the 'beam', which has the added advantage of adding material and weld area in tension; — the direction of highest loading. There are numerous other ways that weld area can also be achieved whilst maintaining aesthetic appearances. TAC members have recommended to TCI that the bracket is redesigned to provide an increased safety factor.

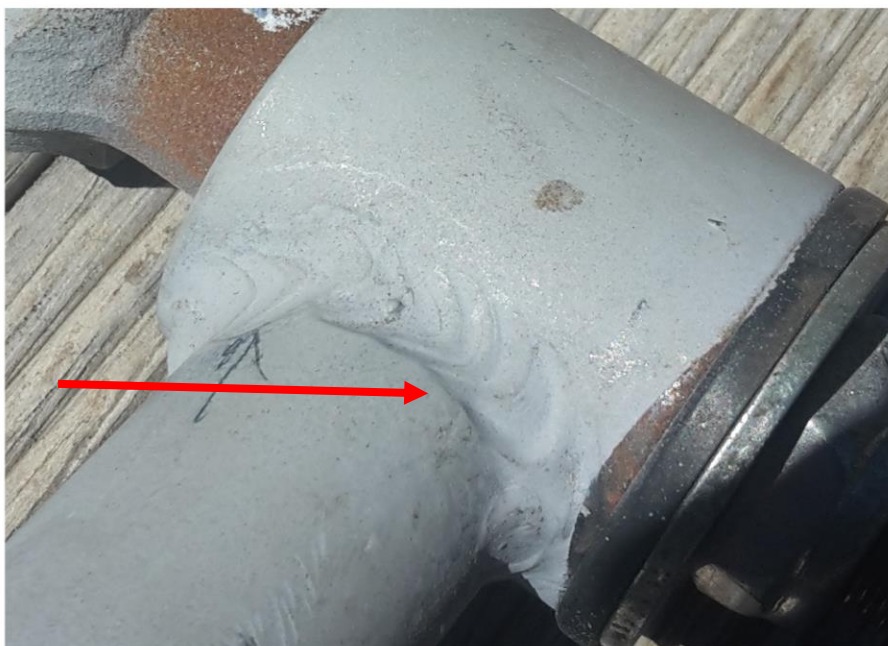
*A weld defect called 'undercut' is visible in this picture. Undercut can result in a significant reduction in weld strength, and also reduction in the material cross-sectional area of the parent metal. This is usually a result of poor fit-up of sections, excessive gaps, and lack of sufficient filler metal in the weld. These issues combine to indicate poor operator technique.*

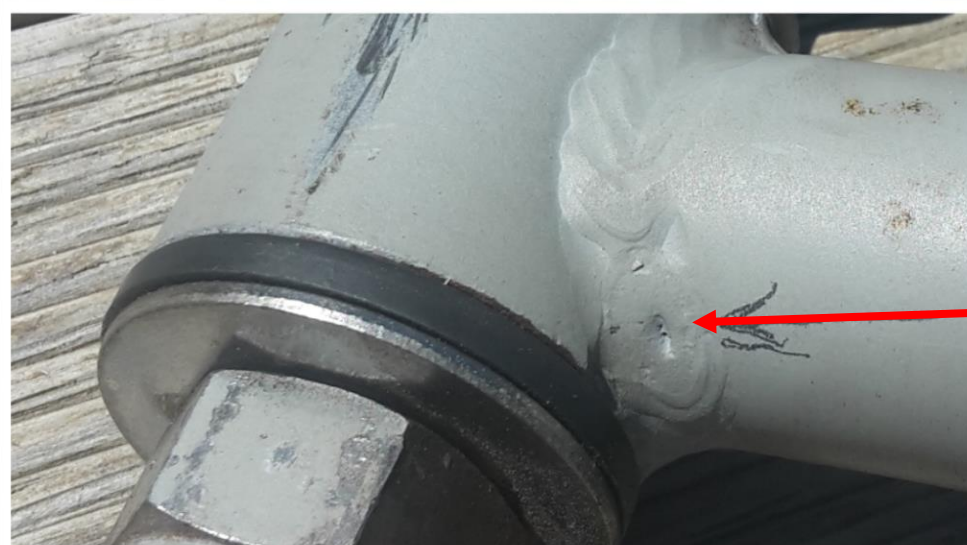
*An undesirable 'crater' can be clearly seen in this photograph. Such an imperfection can cause weakness in the weld, and is caused by poor operator techniques in the start/stop regions of weld.*

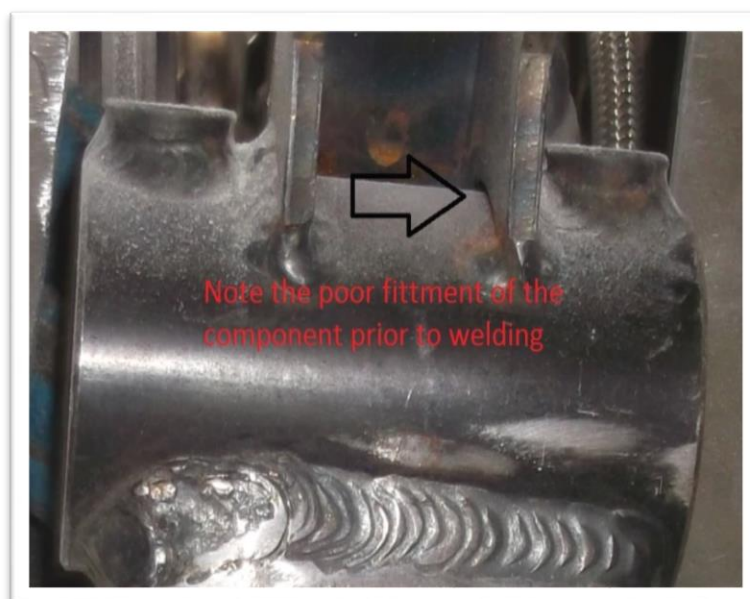
The area inside the coil-over mount must be carefully inspected for any signs of a poor fit-up\* between the bracket and the pivot-tube it is welded to. If any evidence of poor fit-up is evident, the vehicle owner should be advised in writing, on an F004 - LVVTA Rectification Sheet, with a copy retained by the LVV certifier.

\* Poor fit-up in this context is defined as any gap which exists between the two welded sections. When inspecting a vehicle, an LVV Certifier must look for is how well the shock absorber mounting bracket attaches. While the front suspension assembly in most of these vehicles are likely painted, an LVV Certifier should still be able to get an indication of the quality of the fit up of components.

If any poor fit-up between the upper coil-over and the upper A-arm pivot tube is identified, refer to paragraph # 4. The vehicle owner must be advised that rectification work is required, and they should not operate the vehicle until such time as the rectifications have taken place.

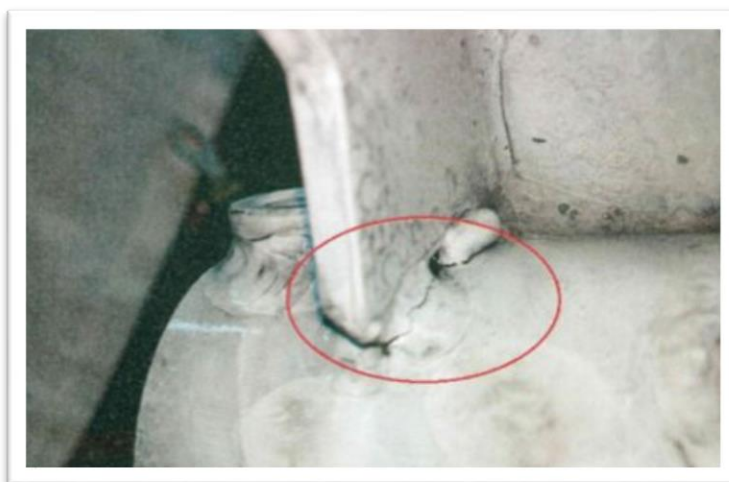
If *any* visible cracking or other significant weld defects are evident, the vehicle owner must be advised that rectification work is required, and they should not continue to operate the vehicle until such time as the rectifications have taken place.
