'Magnum'-brand I-beam Axle Safety Warning

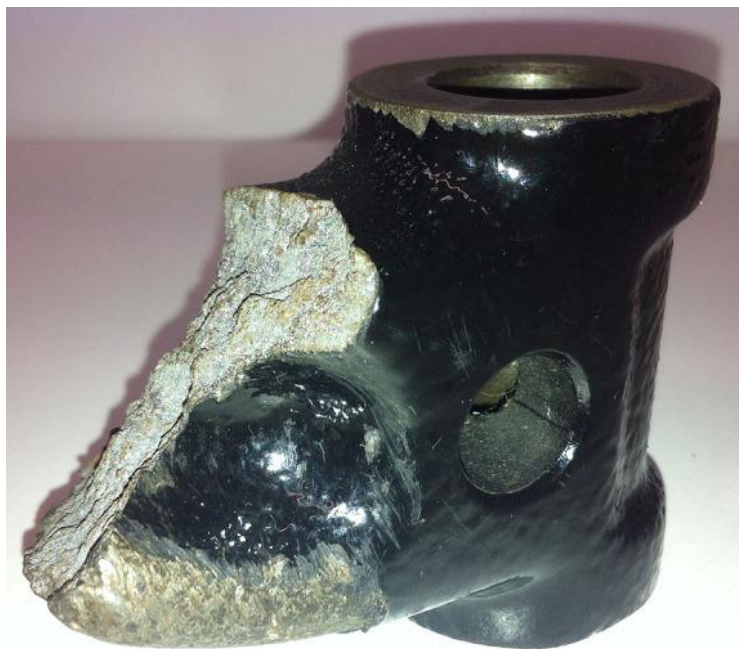
LVVTA has recently been made aware of two instances of catastrophic failures of Magnum brand cast I-beam axles, one in Australia, and one in New Zealand. Other failures have also been reported in the USA. In both of the failures that LVVTA has become aware of, the failure has taken the form of a complete and sudden breakage which has caused a total loss of steering and braking control to the vehicle, due to the collapse of one side of the axle beam.

The investigation has shown thus far that a major manufacturing problem exists within the casting process used in the production of the batch of Magnum-brand axles that included the (New Zealand) failed axle. The full technical findings of this investigation, including details of the molecular structure of the material, and the reasons for its failure, will be provided in detail within a further LVVTA Information Sheet, which will be published in due course.

The principle point, and reason for the issue of this LVVTA Information Sheet, is to make it clear to any interested or affected persons, that this same manufacturing problem will exist in all other axles from the same batch, and any axle from within this batch is likely to suffer exactly the same catastrophic failure. Anyone who owns a Magnum-brand I-beam axle, including any companies stocking any such product, should contact LVVTA for advice. Anyone who owns a vehicle with such an axle fitted should contact LVVTA for advice, and immediately cease using that vehicle until it has been established whether or not the axle fitted to the vehicle is one from the affected batch, as the vehicle may be unsafe.

Where any doubt or question exists, LVVTA strongly recommends that owners of vehicles fitted with an axle which may be one of the affected axles, immediately cease using the vehicle until such time as the axle can be inspected and verified as safe.
