SAFETY ALERT # 05 - 2018

Aftermarket Brake Boosters

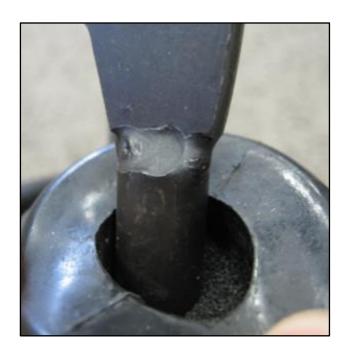
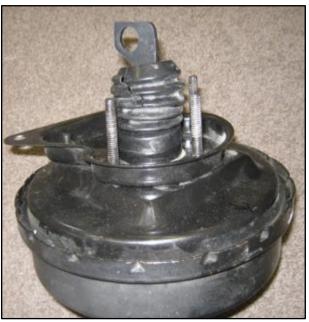
A 'CPP'-branded ('Classic Performance Products') brake booster has been identified as having a welded two-piece brake pedal push-rod.

This is a critical braking component and therefore <u>cannot</u> be welded.

The booster identified was a bolt-on replacement for a Ford Mustang, confirmed as being aftermarket. Upon a cursory glance, the booster looks like any other, but when the rubber dust seal is pulled back to expose the brake pedal push-rod (an item that is customarily one-piece), a welded two-piece rod is found.

LVVTA welding experts within the Technical Advisory Committee (TAC) noted after inspecting the push-rod that the welding was also of poor quality with pronounced undercut causing a reduction in material. One TAC member's comment was that "one side shows obvious undercut and insufficient weld volume".

LVVTA asks that extra care be taken with any boosters that are not, or may not, be an OEM item, to ensure that a similar welded push-rod is not incorporated within the booster assembly. Inspection is simple, and the rectification usually is also straight-forward with the fabrication of a one-piece item.

Any non-OEM brake pedal push-rods must be inspected and confirmed as being one-piece and <u>must not</u> be welded.
