LVVTA

200 Axles Assessed

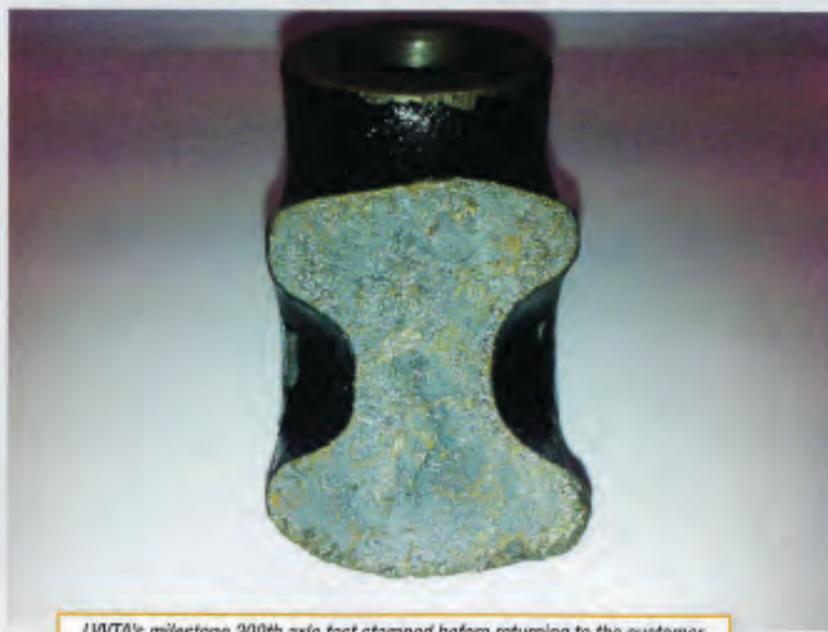
LVVTA's milestone 200th axle test stamped before returning to the customer.

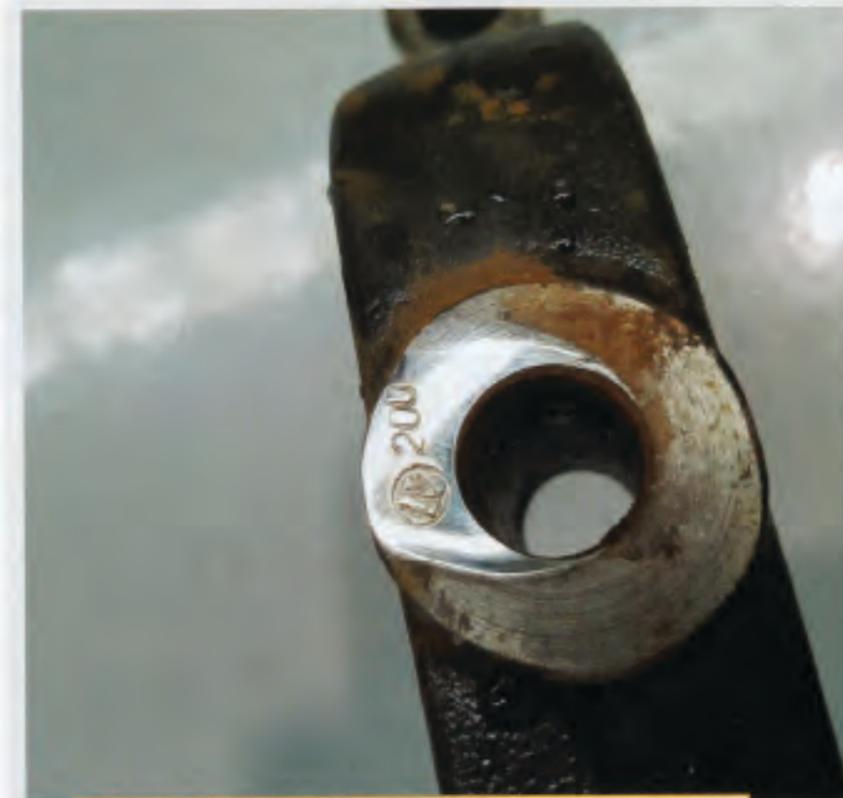
LVVTA's milestone 200th axle test stamped before returning to the customer.
