## Rear Shelf Speaker Aperture Modification

### Background

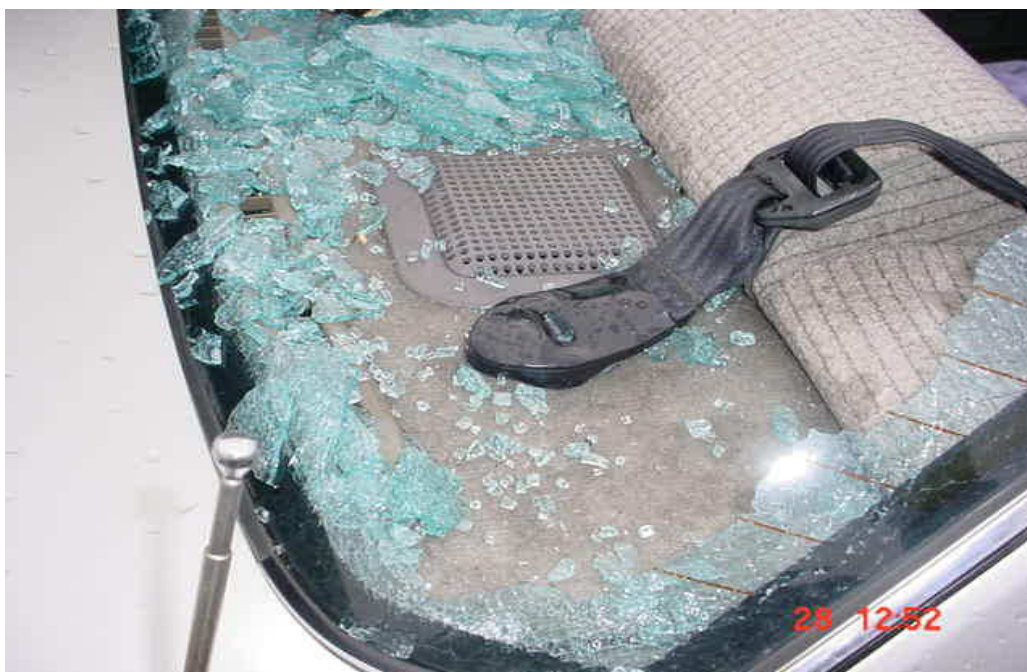
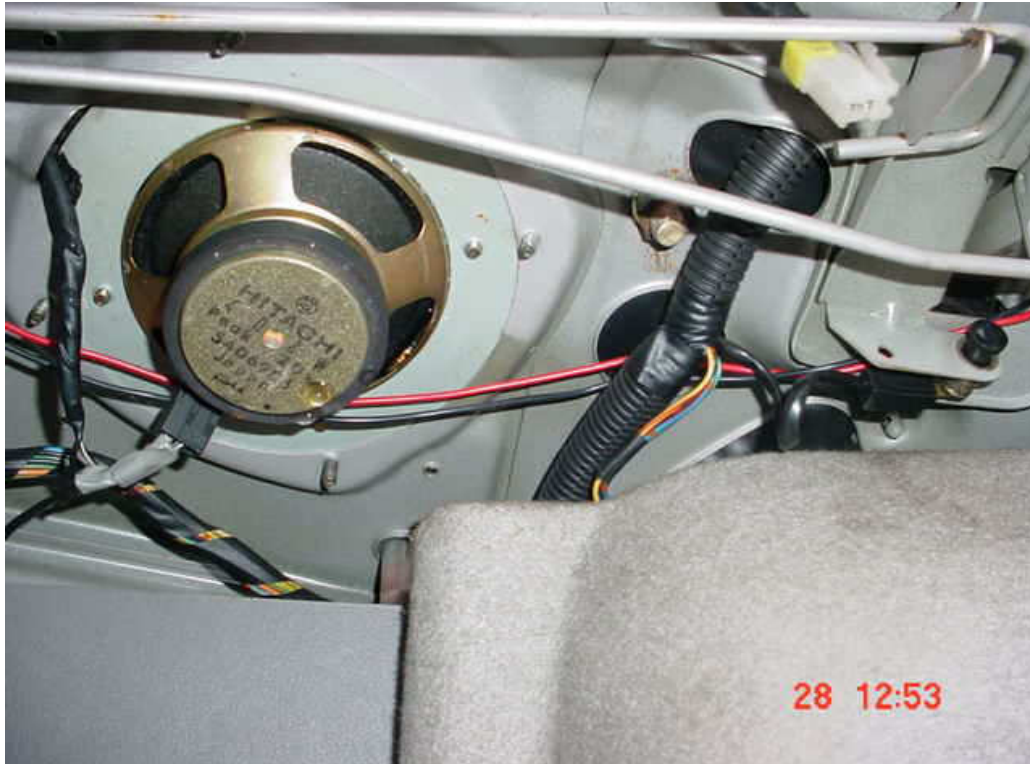
#### **Nissan Bluebird**

This Nissan Bluebird sedan (this photo and next page) has a static upper seatbelt anchorage attached directly to the rear shelf. This is typical of a rear shelf that should never have its speaker aperture increased in size without having the vehicle LVV certified.

A rear shelf which has an upper seatbelt anchorage attached directly into the shelf, and has an enlarged speaker aperture (or any other structural modification for that matter) must be referred to a LVV certifier, who will ensure that any strength lost to the shelf as a result of the modification will be reinstated by some suitable method.
