## Nissan Terrano D21 Rear Seatbelt Anchorage/Floor Rust Problem and LVV Modification Solution

**This Infosheet replaces Infosheet #02-2004**

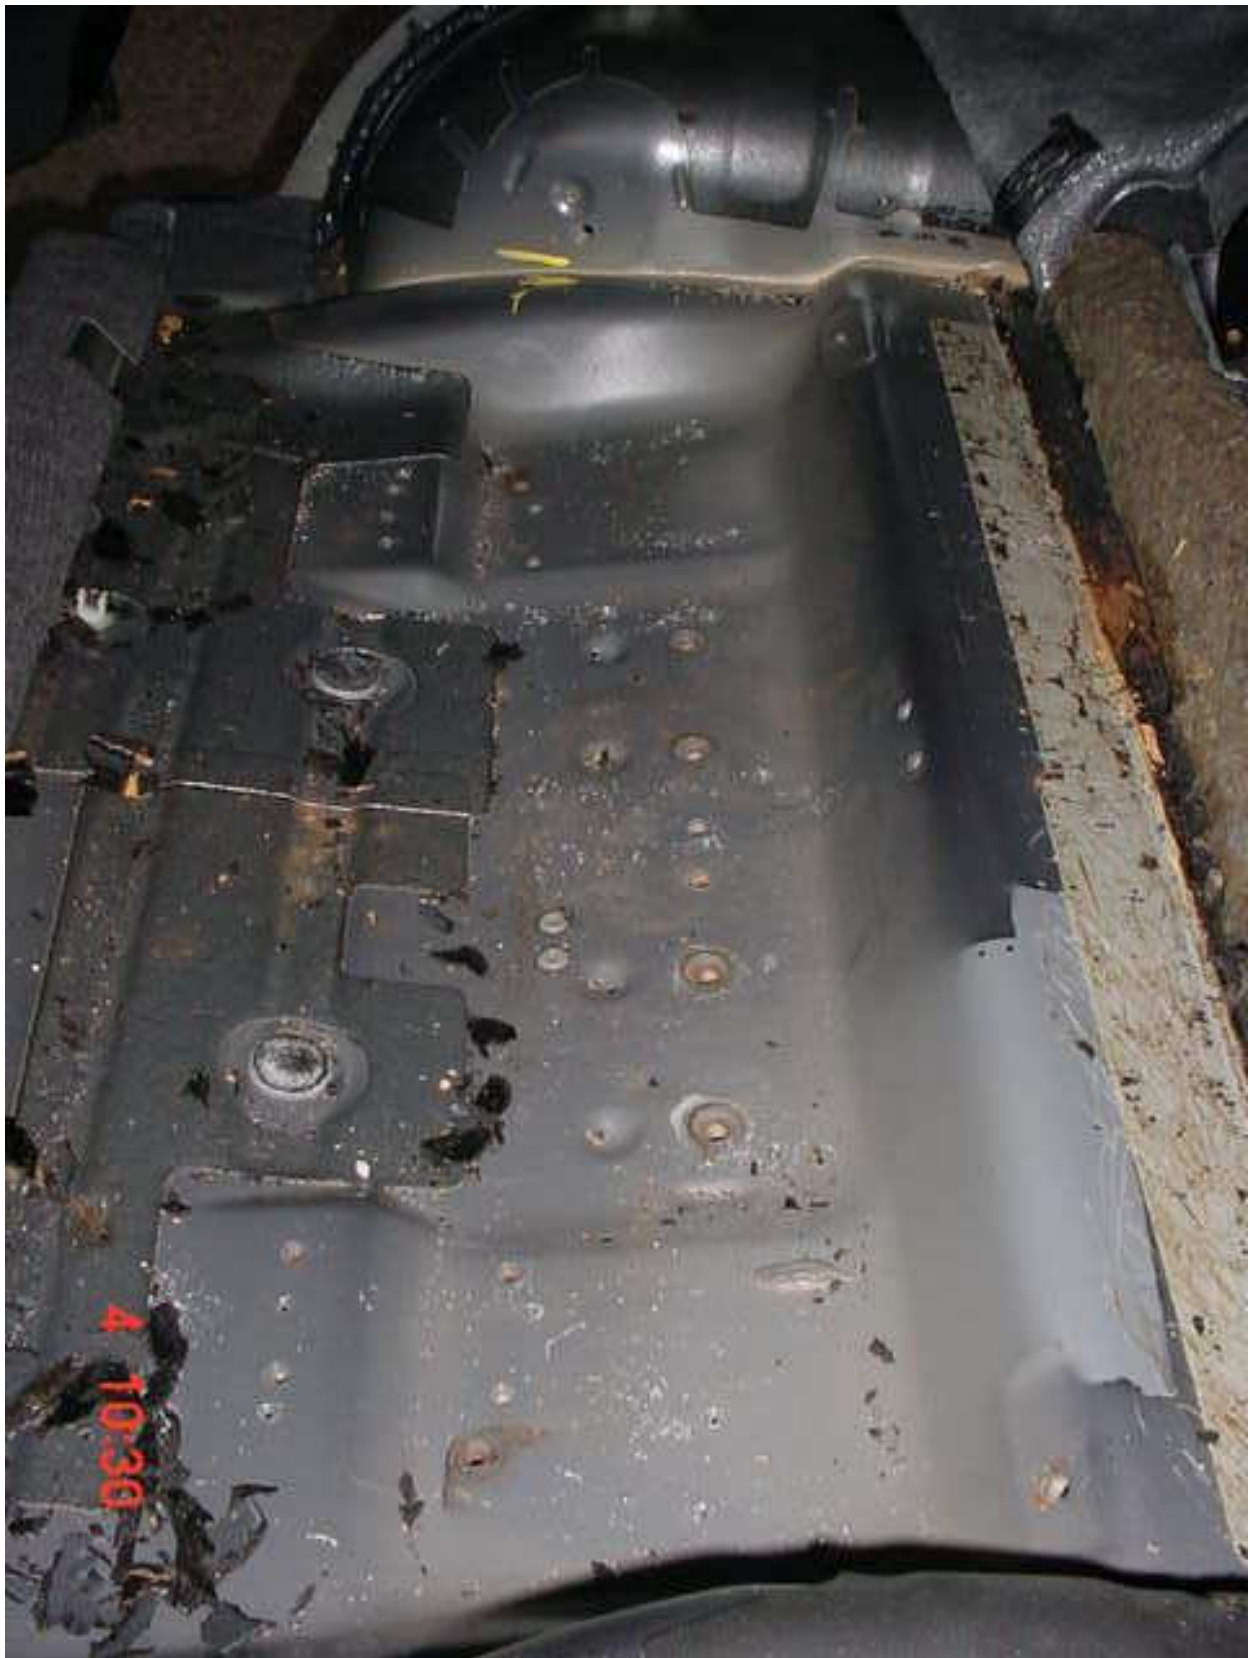
Terrano floor, inside vehicle, with seat removed, photo taken from left rear door opening, very little visible rust was showing in the interior of this vehicle.

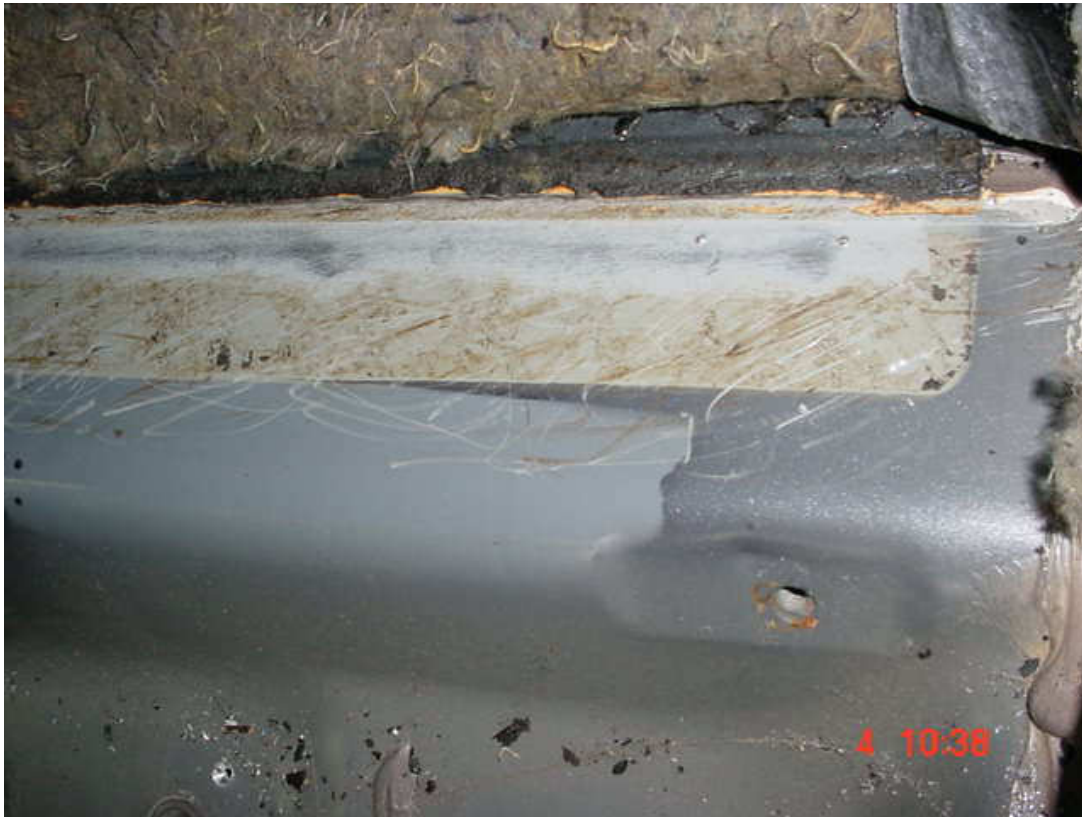
Interior of vehicle floor, stripped back to bare steel with wire wheel to reveal spot-welds.

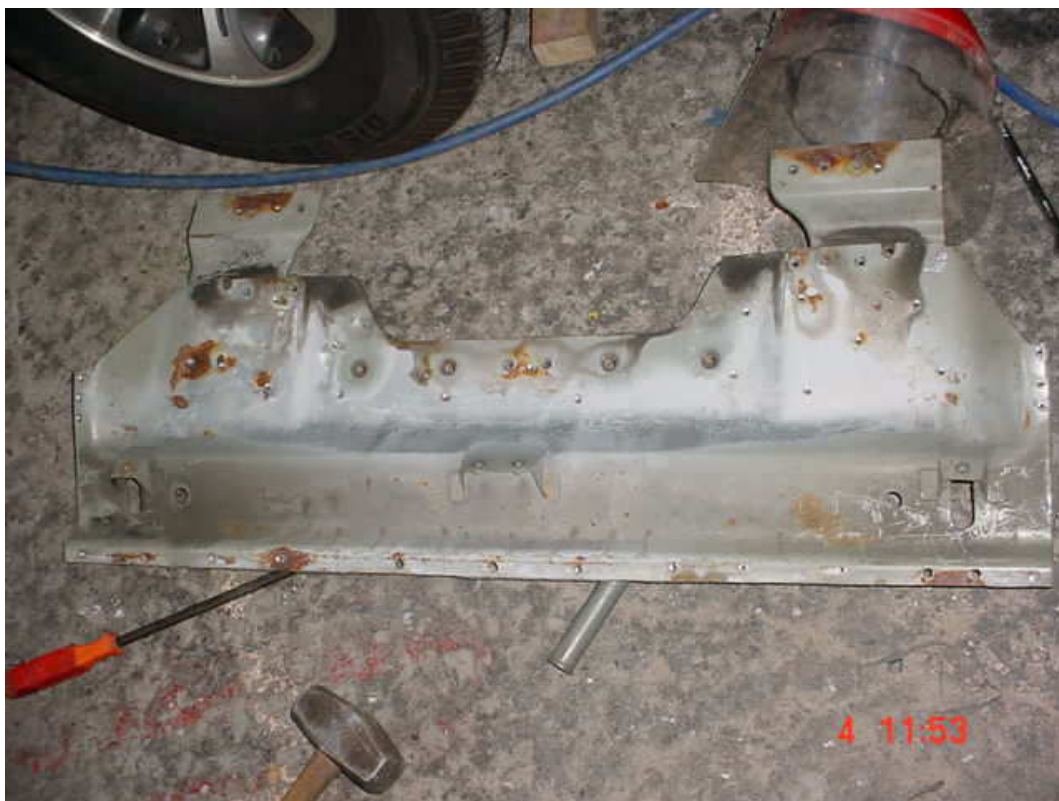
The reinforcing plate upper face (hidden from view when in the vehicle) is inspected. This example is one of the better ones. Any patch repairs to the reinforcing plate are done at this stage.

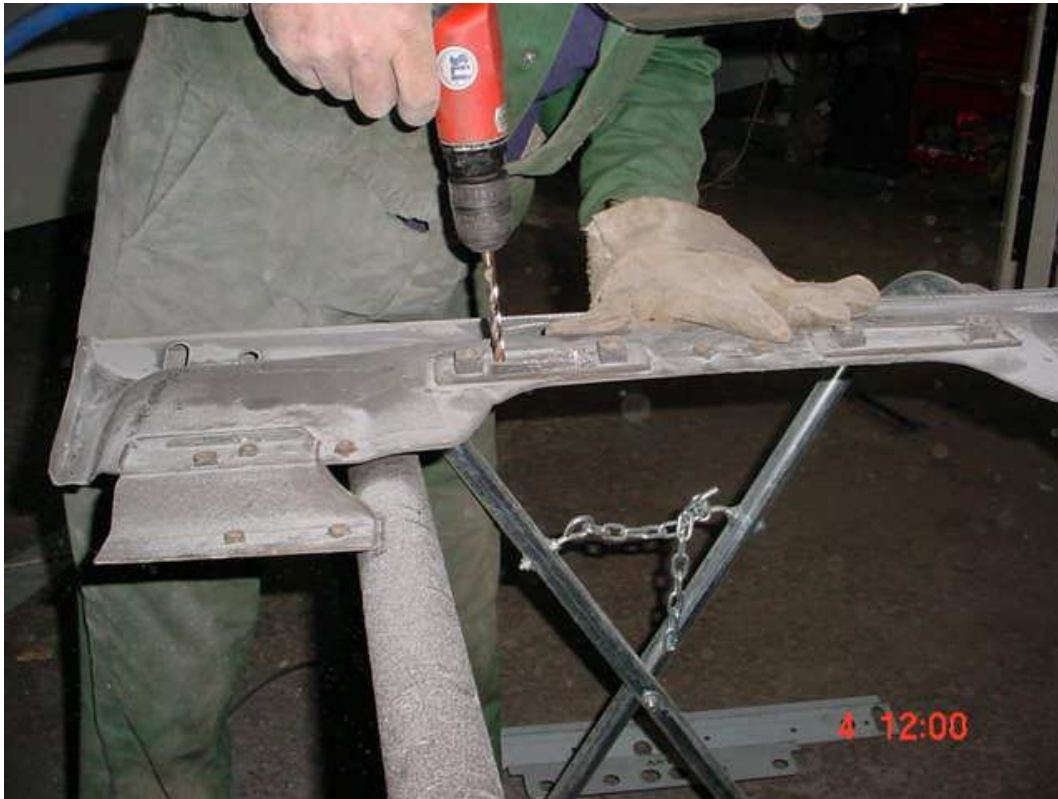
The spot welds holding the seat-belt anchorages to the reinforcing plate are drilled through 2mm (both layers) then 8.5 mm through the anchorage plate only (1 layer).

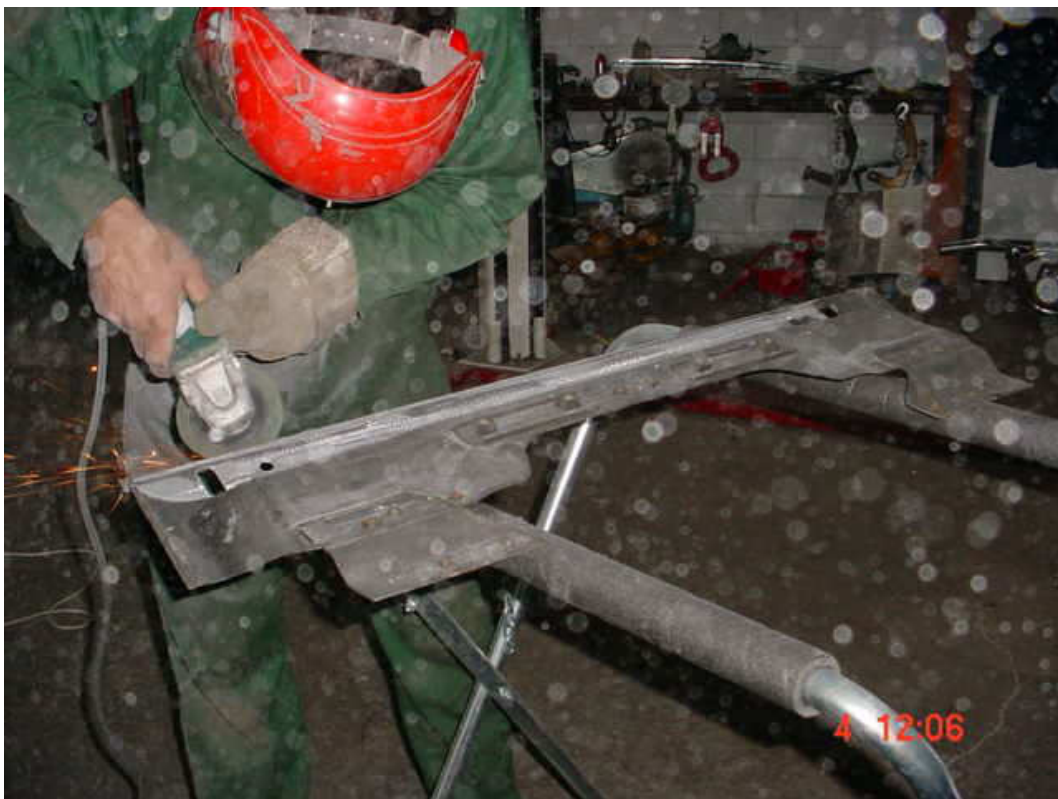
The reinforcing plate underside is cleaned to bare metal by wire-wheel and grinding to remove rust, etc and where the LVV load-bar overlaps.

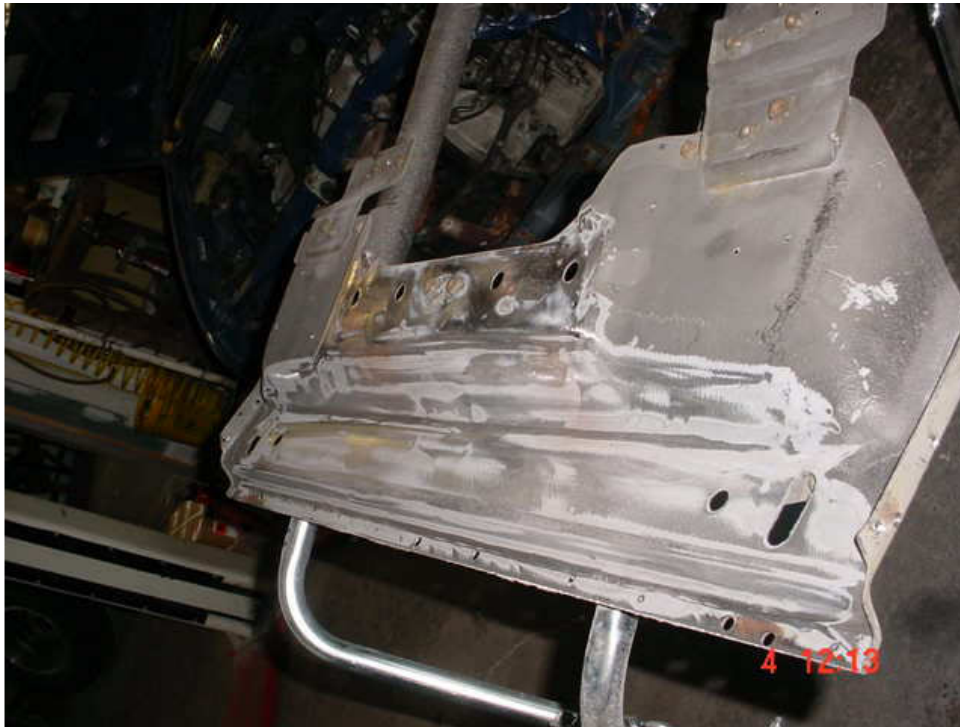
The underside of the OE reinforcing plate has been cleaned back to bare metal where there are any signs of rust, and where the LVV load-bar overlaps it. It is treated using automotive corrosion-converter then automotive epoxy primer over the whole mating surface, followed by weld-through primer where welding will occur. Six 8.5 mm holes have been drilled through the lower edge in the photo for plug-welding to the LVV load-bar.

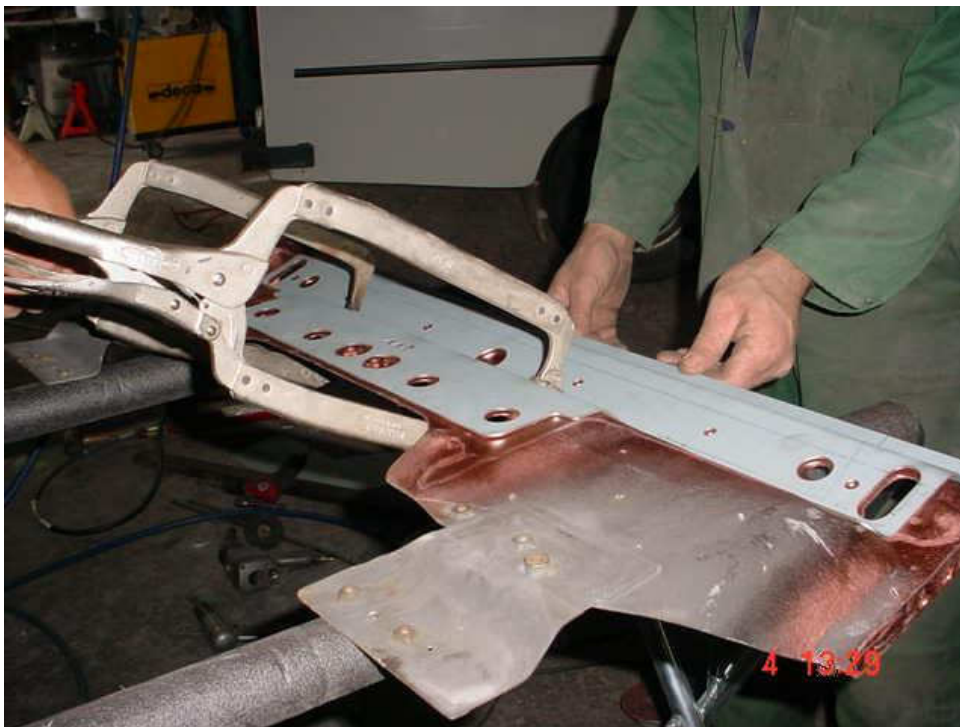
The LVV load bar is clamped and aligned to the OE reinforcing plate.

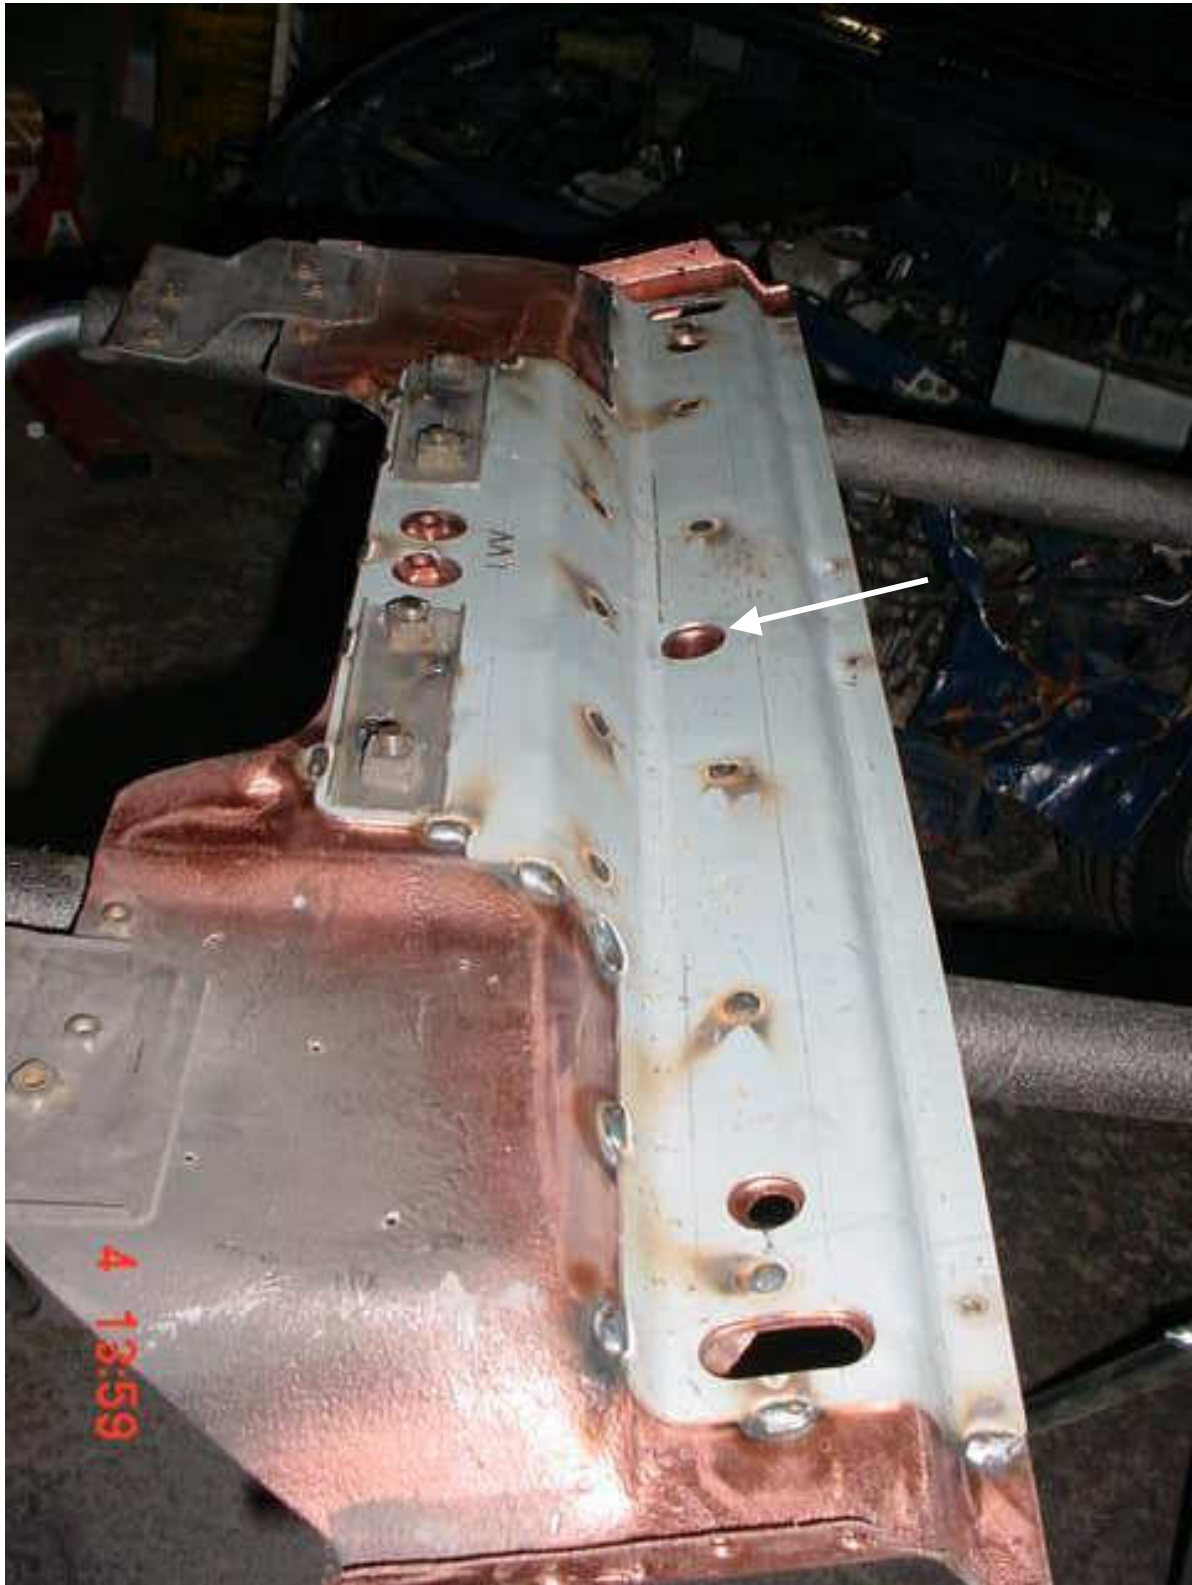
Plug welding of LVV load-bar and seat-belt anchorages is completed. The arrow shows where a 12 mm hole may need to be drilled to allow for injecting penetrating rust-proofing coating later.

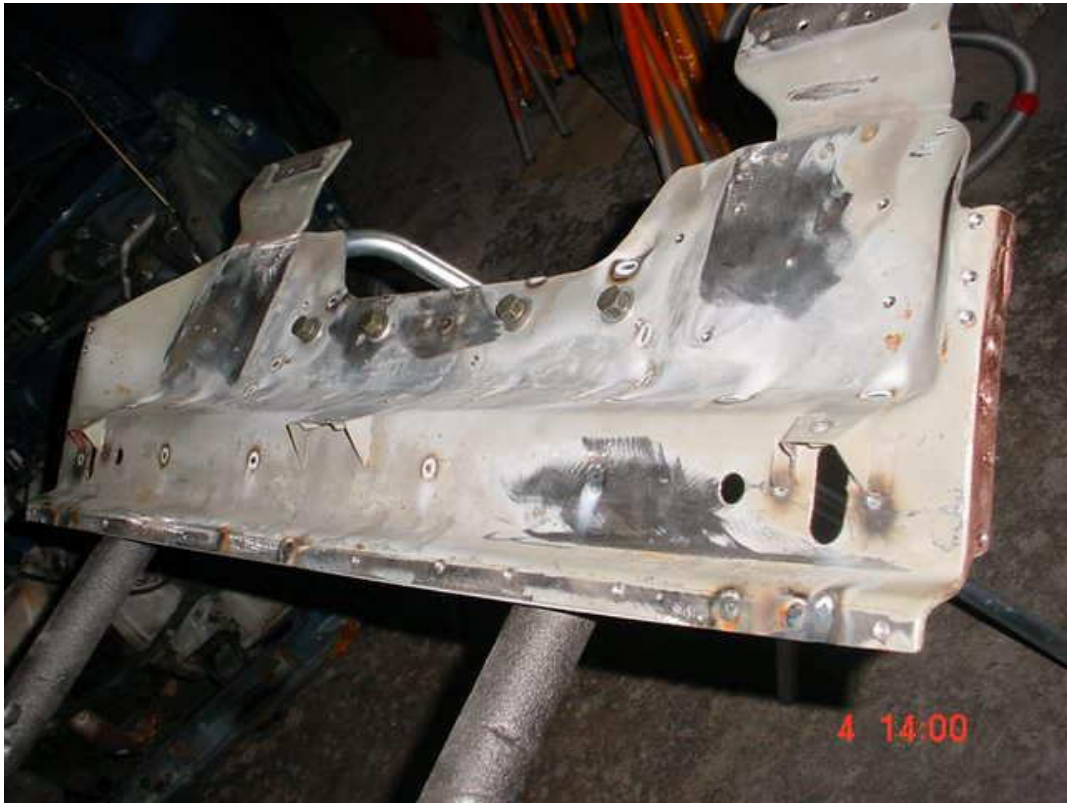
Assembly is turned over and plug-welded from topside of reinforcing plate at 6 locations on rear edge. This attaches the load-bar at this edge. These holes were pre-drilled – see photo L.
