Helping New Zealanders Build & Modify Safe Vehicles

AFTERMARKET CHROME BRAKE BOOSTER BOLT FAILURE

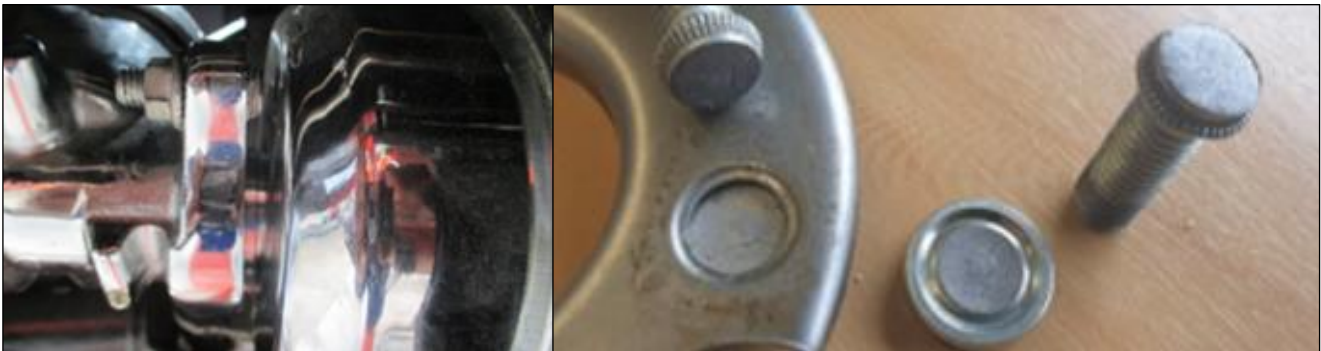
LVVTA has recently become aware of several aftermarket chrome brake booster bolt failures. Three cases have been reported to LVVTA involving chrome 8-inch dual-diaphragm boosters in which the studs holding the master-cylinder to the booster have broken at the point at which they crimp to the booster.

One of the boosters had CPP (Classic Performance Products) brand markings on it (part number 8DSRB), however the other boosters could not be identified.

LVVTA sent the broken studs and an OEM stud to a metallurgist for examination and comparison. The fracture face and microstructure were analysed, and a chemical analysis was carried out. The results showed the aftermarket booster studs broke from a single event rather than from fatigue, and the overall hardness of the straight section of the shank was 190HV (‘Vickers’-type hardness measurement) compared to 350HV for the OEM stud. The metallurgist concluded that:

“The fractured brake booster bolt is forged from a low carbon steel and is in the as-forged condition. The high-stressed head has fractured off. The fractured brake booster bolts are poor quality compared to the quenched and tempered higher strength OEM brake booster bolt.”

Potentially-affected vehicle owners should cease driving the vehicle, and make contact with an LVV Certifier in order to determine whether the brake booster fitted to their vehicle is of the type detailed in this Safety Alert.

When certifying a vehicle fitted with a chrome 8-inch dual-diaphragm booster, LVV Certifiers must ensure that the bolts securing it to the brake master-cylinder are torqued to 27 Newton-meters (20 Foot-pounds) as part of their inspection.
