**SAFETY ALERT**  
**Kit Car Steering Column Shafts**

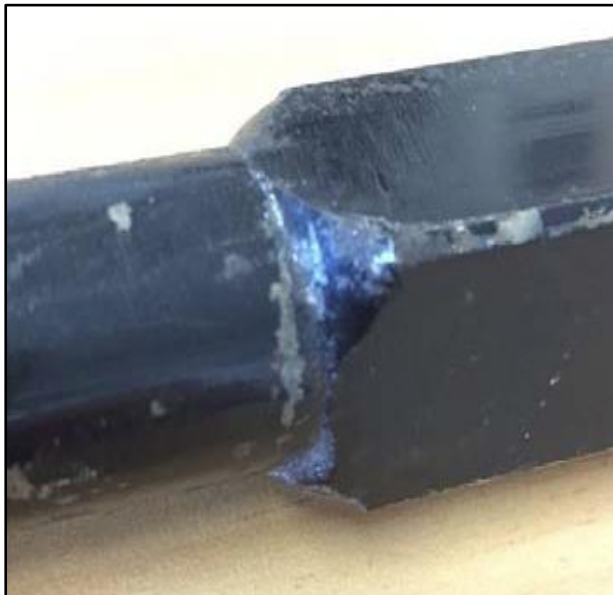
The first vehicle was a South African-built 1995 Birkin Lotus 7 replica. The shaft was constructed of thin-walled square-section tube (19mm x 1.4mm) which is not adequate from a strength point of view. The attaching welds were of very poor quality and had been ground down.

All non-OEM steering shafts and columns must be inspected and confirmed as being one-piece. Any welded steering column shafts cannot be LVV certified.

All non-OEM steering shafts and columns must be inspected and confirmed as being one-piece. For more information relating to the correct manufacture of steering columns, see Chapter 18 - Attachment Systems and Chapter 7 – Steering Systems of the NZ Car Construction Manual.

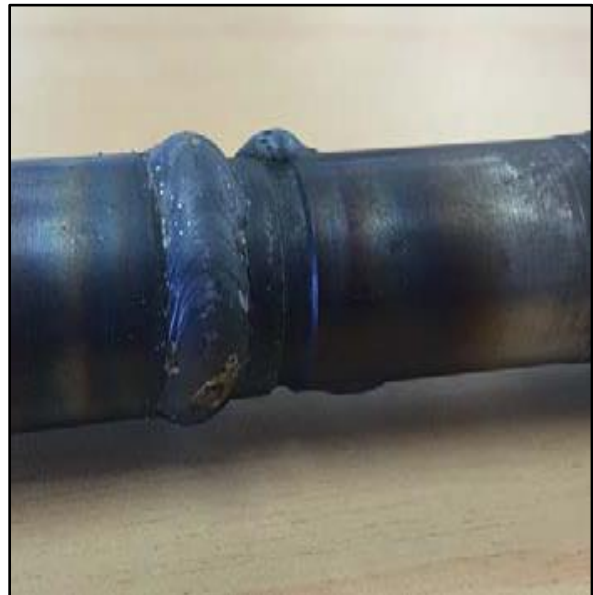
The second vehicle was a UK-built SS Jaguar replica. This shaft comprised two shafts of slightly varying sizes which had been welded together and appeared to have a spigot. There was also a collar, which had been welded to the shaft to allow for a steering lock, which could potentially be hiding other faults.
