Helping New Zealanders Build & Modify Safe Vehicles

### Aftermarket Tubular Suspension Arms with Cantilever-style Ball Joints

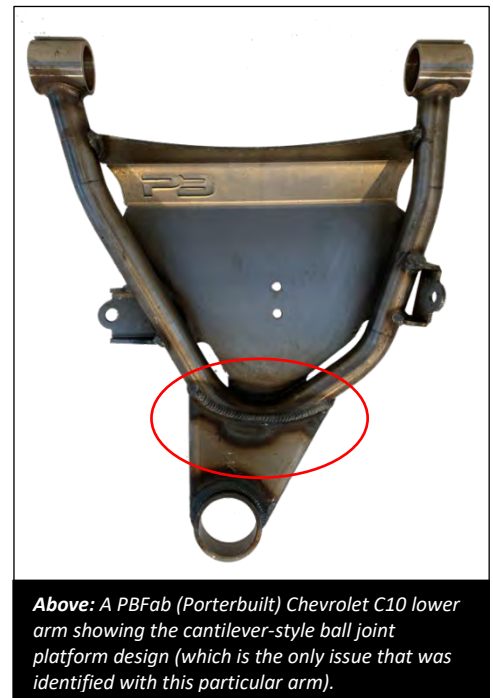
*Above: A PBFab (Porterbuilt) Chevrolet C10 lower arm showing the cantilever-style ball joint platform design (which is the only issue that was identified with this particular arm).*

**An LVV Certifier presented with a vehicle fitted with cantilever-style suspension arms, must either confirm that rectifications are not required, or that the arms have been rectified as per the applicable Information Sheet, and thoroughly inspect the components to confirm no weld defects are present.**
