LVVTA

200 Axles Assessed

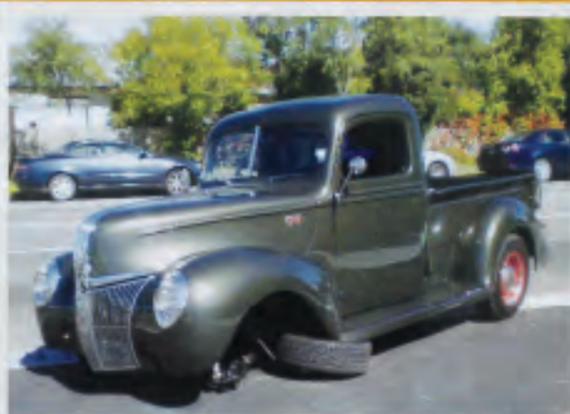
It was the failure of one Magnum-brand cast iron I-beam axle in 2012 which first brought to LVVTA's attention the sub-standard casting process which had been adopted by some I-beam axle manufacturers. The failure of that axle and subsequent failures of other Magnum-brand axles in other countries led LVVTA to establish a cast axle testing and inspection process. In late January 2018, the milestone 200th axle was inspected, and as with all before it, either assured of being safe or scrapped and replaced with a safe axle.

A nodularity rating of 80% is the global standard for which cast components such as axles must meet or exceed to be considered 'nodular iron', however, of the 200 axles LVVTA have processed to date, an alarming 25% have failed to reach this level, with many coming in as low as 20% nodularity, and one at an astounding 10% nodularity.
