Power Steering Torsion Bar Modification

Background:

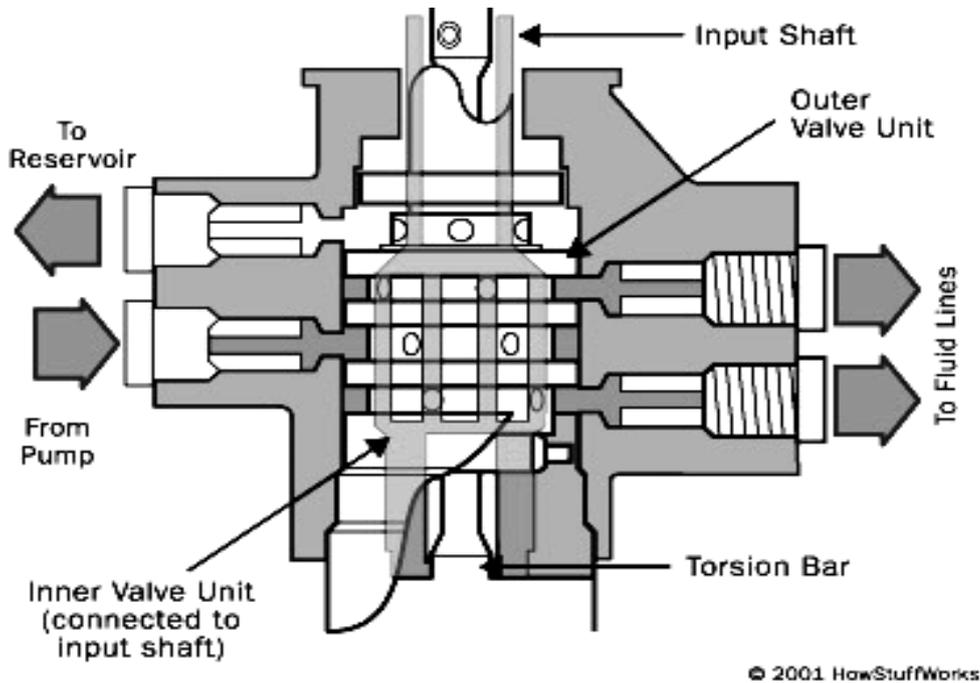
As the torsion bar twists, it rotates the inside of the spool valve relative to the outside. Because the inner part of the spool valve is also connected to the steering shaft (and therefore to the steering wheel), the amount of rotation between the inner and outer parts of the spool valve depends on how much torque the driver applies to the steering wheel.

When the steering wheel is not being turned, both hydraulic lines provide the same amount of pressure to the steering gear. However, if the spool valve is turned one way or the other, ports open up to provide high-pressure fluid to the appropriate line.

Illustration courtesy of HowStuffWorks.com.
