'Supreme'- brand aftermarket wheels

This LVV Information Sheet has been compiled in order to assist LVV Certifiers to accurately identify and determine the aftermarket wheels known as 'Astro supreme' brand wheels, and to provide guidance on how to deal with them when presented with a vehicle for LVV certification fitted with the wheels.

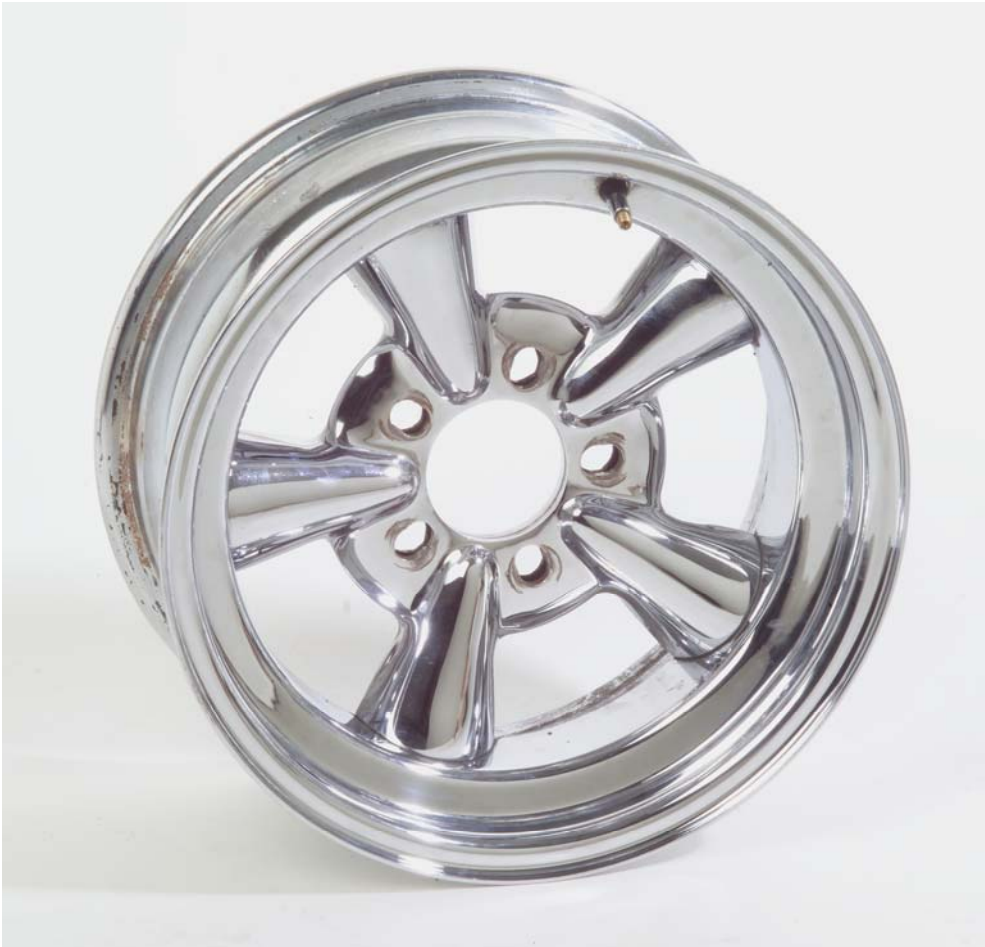
Front face of typical 'Supreme' brand wheel

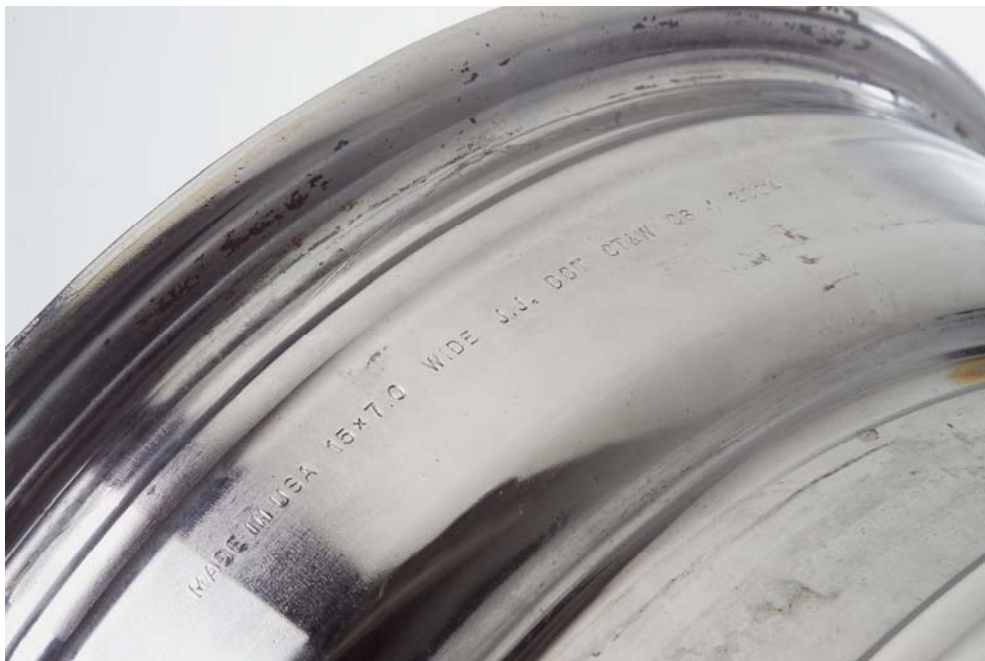
'DOT' compliance marking is evident on rim, but that applies only to the rim itself, not the manufactured wheel.

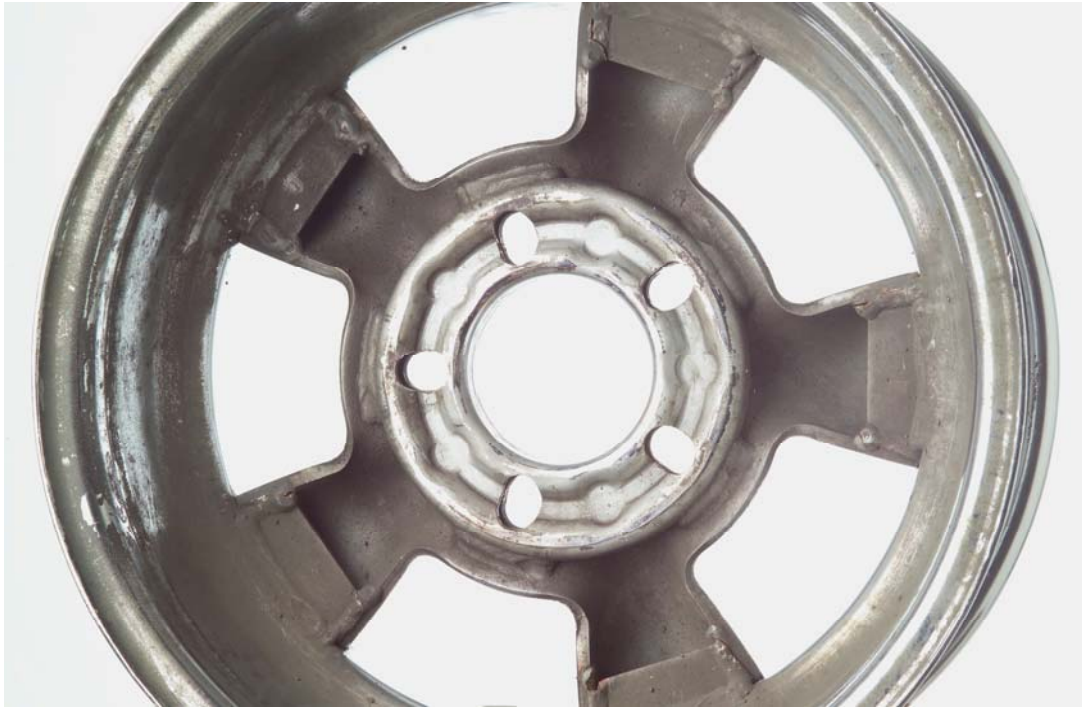
The weld-lugs will be clearly visible with the wheel removed from the vehicle, to which, in turn, the separate centre section of the wheel is welded. Upon close inspection of the wheel, it is likely that the failed welds will be evident to the naked eye.

View of back-face of poorly designed and assembled 'Supreme' wheel.

Any wheels that are designed and manufactured in the same way as the ones described here-in, and as shown in the photographs in this Information Sheet, may not be LVV certified. This is regardless of the vehicle's build-date, or date of purchase or fitment of the wheels. The wheels are a known safety risk, and the LVV system must not allow their continued use.

LVV certification must be refused to any vehicle fitted with these wheels, with the sole exception of the rear of trikes, provided that:

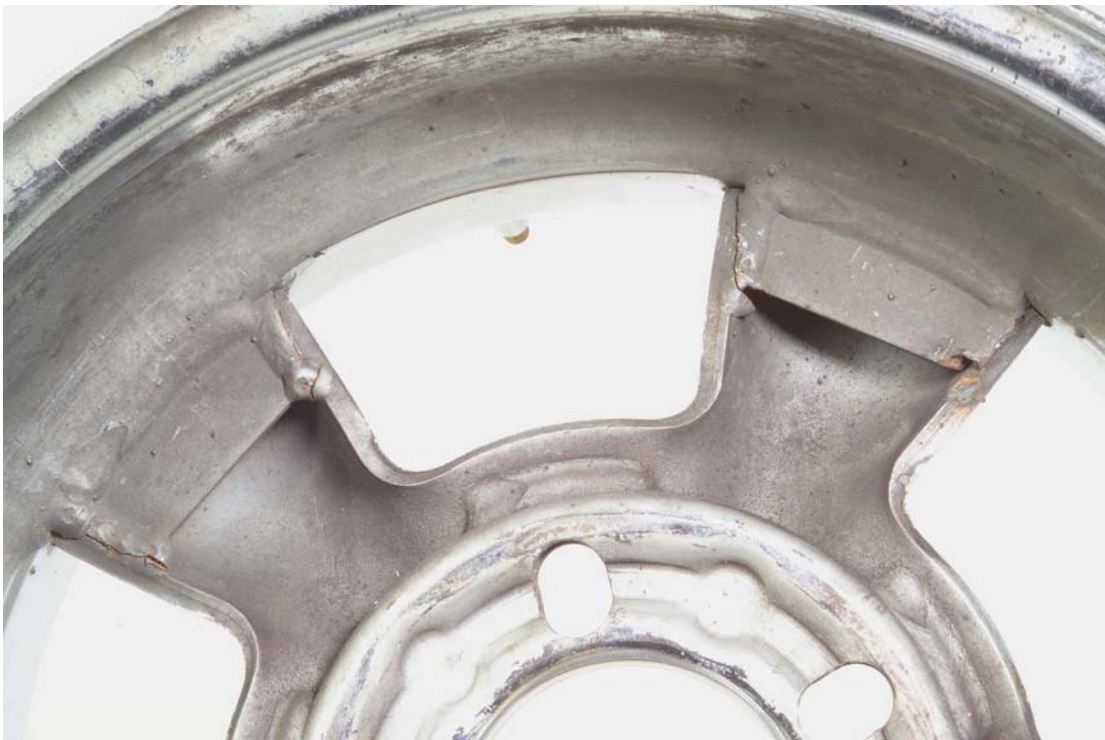
It is LVVTA's opinion, which is shared by LVV Certifiers throughout NZ that we have shown these wheels to, that these wheels are both of a very poor design, and utilise an equally poor assembly process. Typically, the weld quality is very poor, and is prone to fatigue cracking, and eventually, completely separating. If such a wheel that you are inspecting isn't cracked yet, it probably will eventually. All such wheels are at risk of complete failure.

Popular opinion is that because the 'welder' engaged in joining the chromed centre section to the chrome rim (with weld-lugs attached to the rim) has the challenge of doing so without burning the chrome on the spokes of the centre section, the obvious solution is to keep the amperage of the welder deliberately low during the final welds so as not to discolour (burn) the chrome plating. One of our Kiwi car builders working in southern California has been into two of these 'Supreme' wheel assembly shops in Southern California, and he describes the welding processes going on in both shops as 'certainly questionable' at best.

Close-up view of where the weld-lug has been poorly welded to the centre section spokes, and failed.

- the tare of the trike does not exceed 500 Kgs; and
- the wheels have been subjected to an appropriate method of non-destructive testing for cracking, and have been found to have no defects.

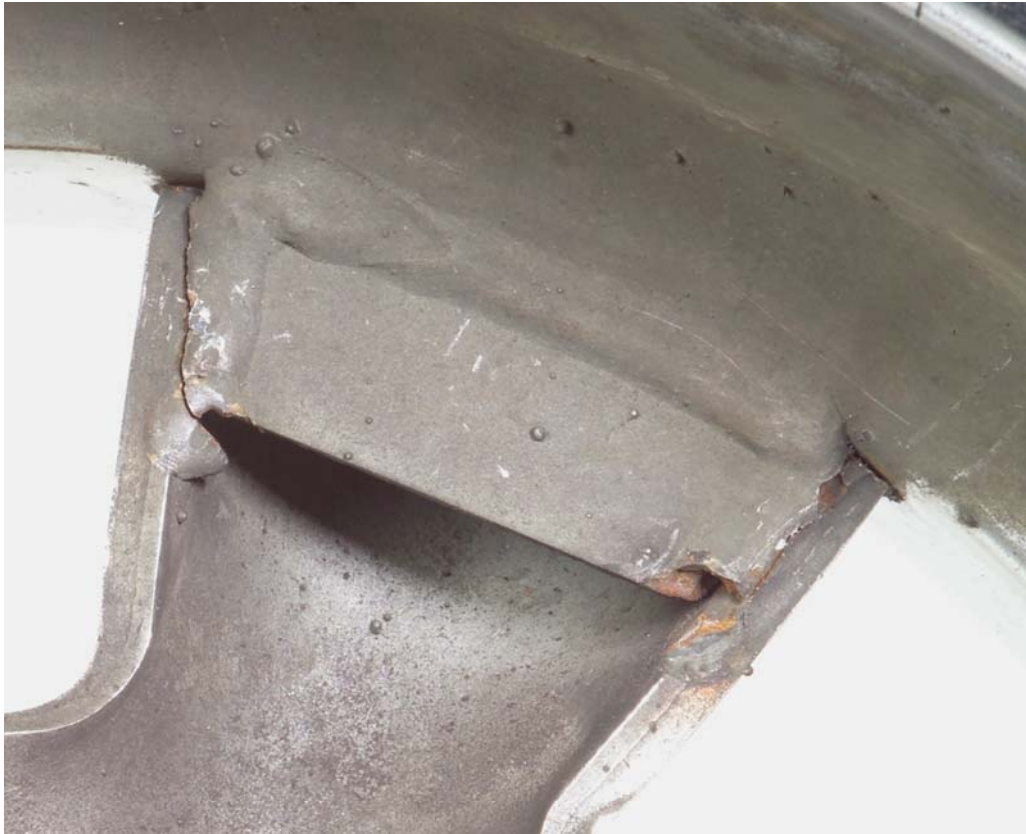
Closer view still, of weld failures.
