'Supreme' – brand aftermarket wheels

This LVV Information Sheet has been compiled in order to assist LVV Certifiers to accurately identify and determine the aftermarket wheels known as 'Astro supreme' brand wheels, and to provide guidance on how to deal with them when presented with a vehicle for LVV certification fitted with the wheels.

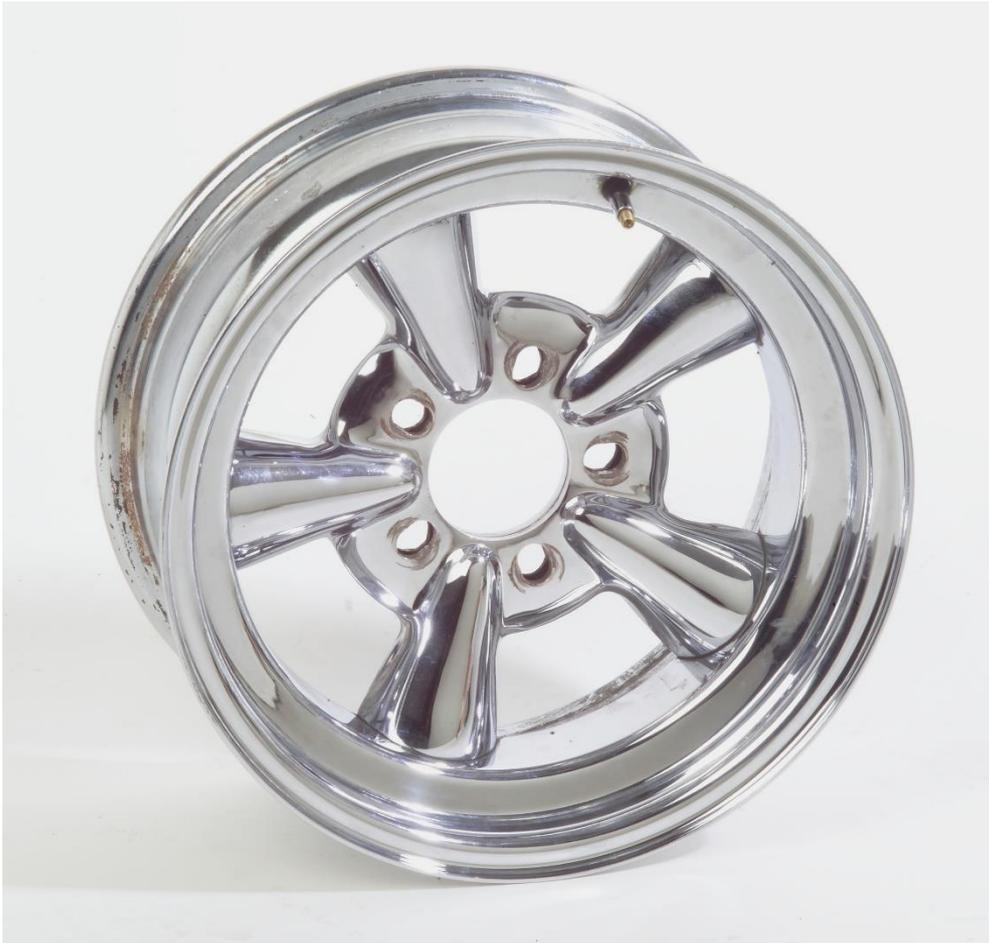
Front face of typical 'Supreme' brand wheel

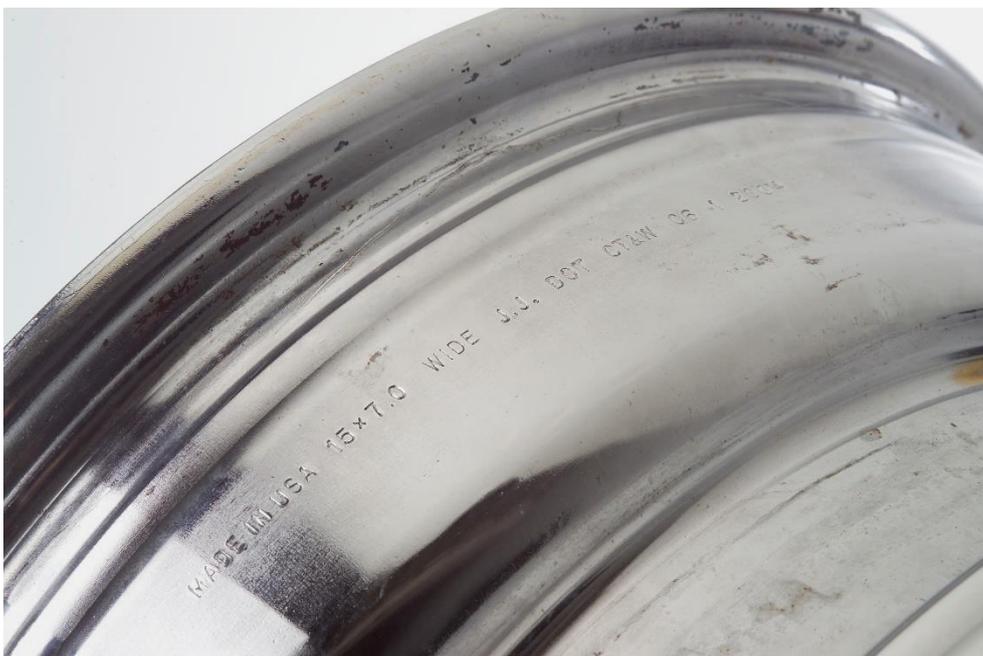
'DOT' compliance marking is evident on rim, but that applies only to the rim itself, not the manufactured wheel.

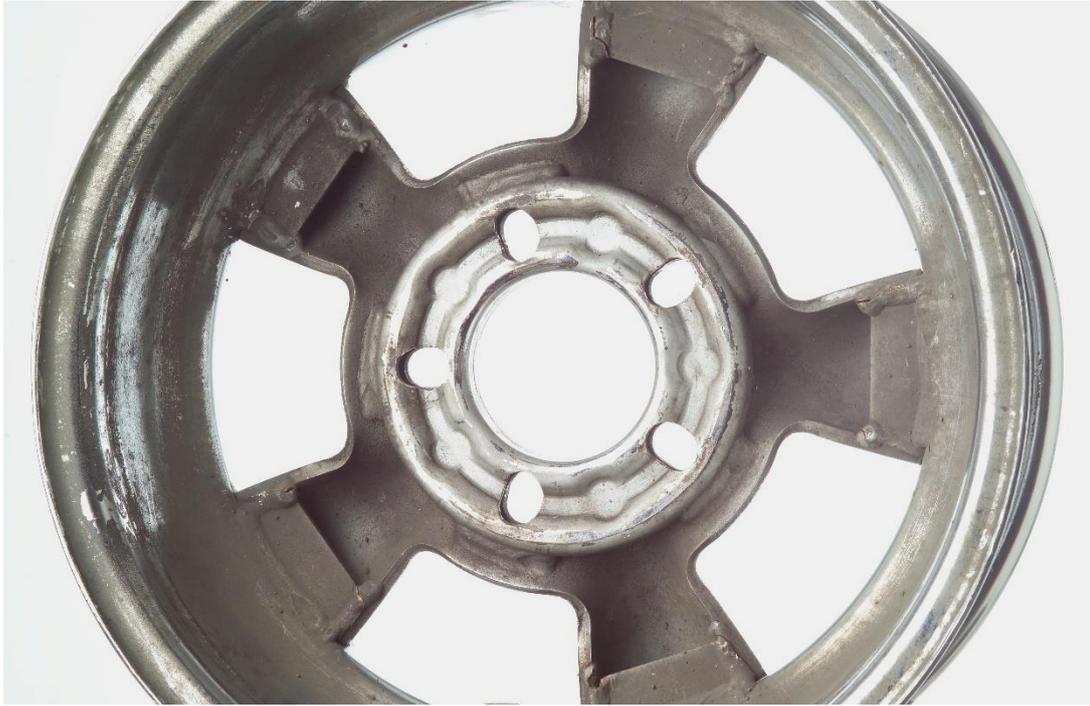
The weld-lugs will be clearly visible with the wheel removed from the vehicle, to which, in turn, the separate centre section of the wheel is welded. Upon close inspection of the wheel, it is likely that the failed welds will be evident to the naked eye.

View of back-face of poorly designed and assembled 'Supreme' wheel.

Any wheels that are designed and manufactured in the same way as the ones described here-in, and as shown in the photographs in this Information Sheet, may not be LVV certified. This is regardless of the vehicle's build-date, or date of purchase or fitment of the wheels. The wheels are a known safety risk, and the LVV system must not allow their continued use.

LVV certification must be refused to any vehicle fitted with these wheels, with the sole exception of the rear of trikes, provided that:

- the tare of the trike does not exceed 500 Kgs; and
- the wheels have been subjected to an appropriate method of non-destructive testing for cracking, and have been found to have no defects.

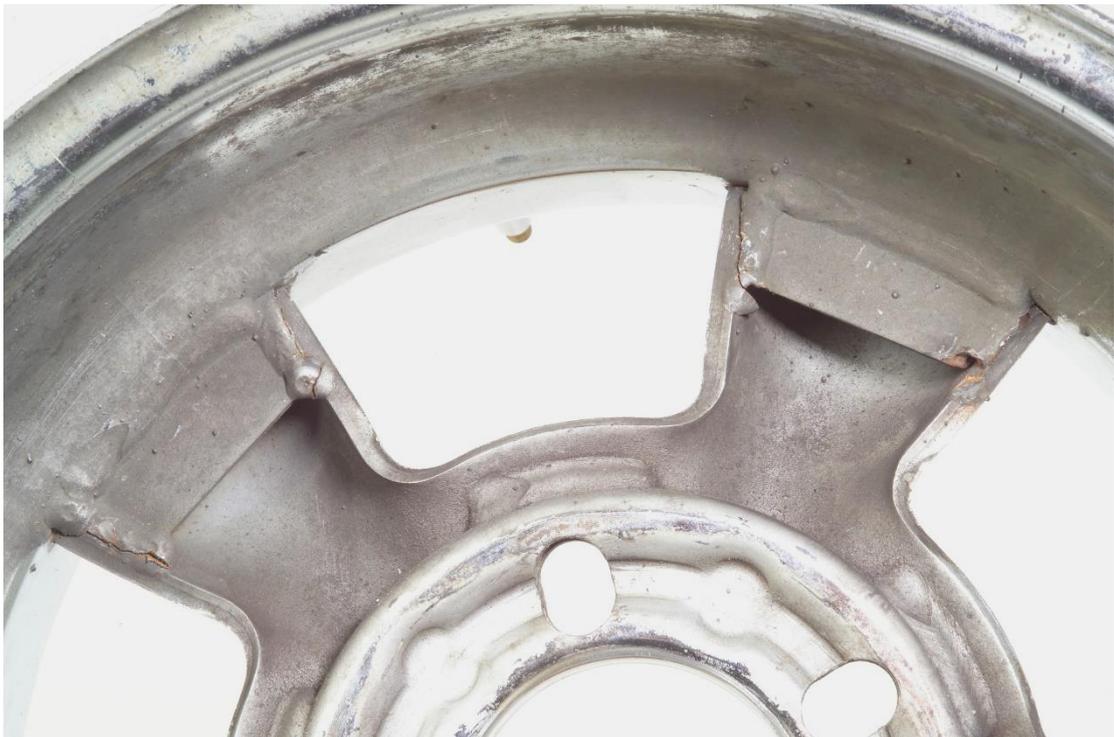
It is LVVTA's opinion, which is shared by LVV Certifiers throughout NZ that we have shown these wheels to, that these wheels are both of a very poor design, and utilise an equally poor assembly process. Typically, the weld quality is very poor, and is prone to fatigue cracking, and eventually, completely separating. If such a wheel that you are inspecting isn't cracked yet, it probably will eventually. All such wheels are at risk of complete failure.

Popular opinion is that because the 'welder' engaged in joining the chromed centre section to the chrome rim (with weld-lugs attached to the rim) has the challenge of doing so without burning the chrome on the spokes of the centre section, the obvious solution is to keep the amperage of the welder deliberately low during the final welds so as not to discolour (burn) the chrome plating. One of our Kiwi car builders working in southern California has been into two of these 'Supreme' wheel assembly shops in Southern California, and he describes the welding processes going on in both shops as 'certainly questionable' at best.

Close-up view of where the weld-lug has been poorly welded to the centre section spokes, and failed.

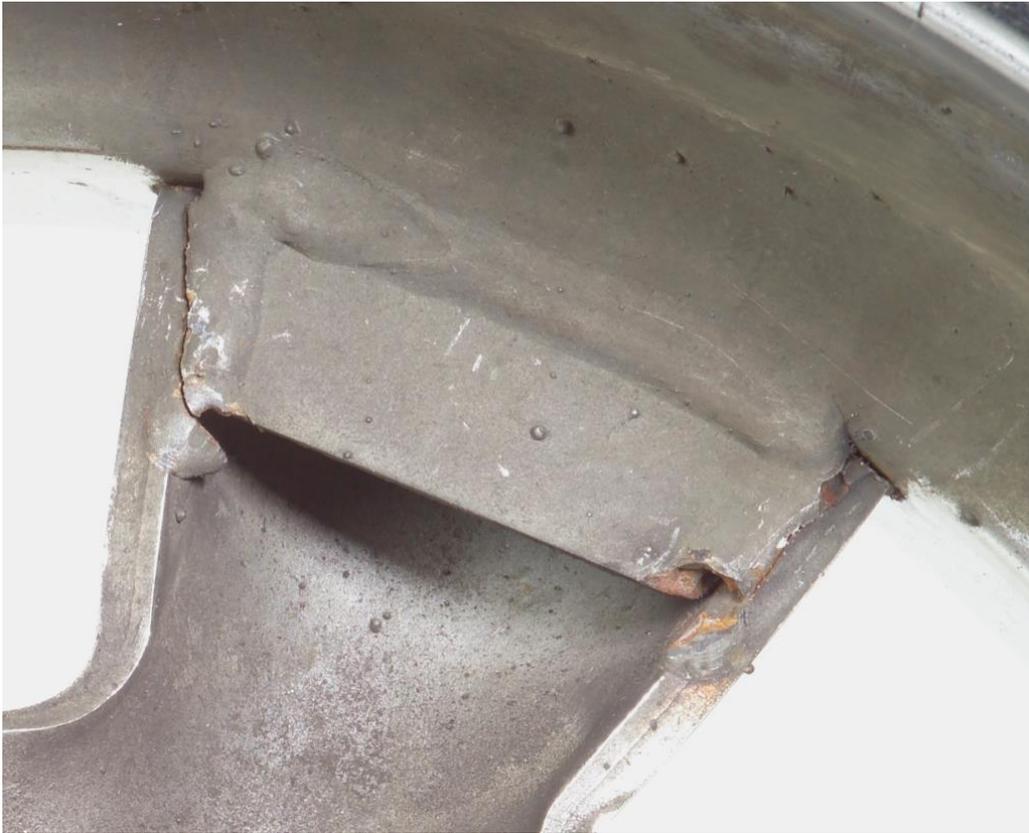
Closer view still, of weld failures.
