Helping New Zealanders Build & Modify Safe Vehicles

## COPIES OF 'ASTRO SUPREME'-BRAND WHEELS

### ► Introduction

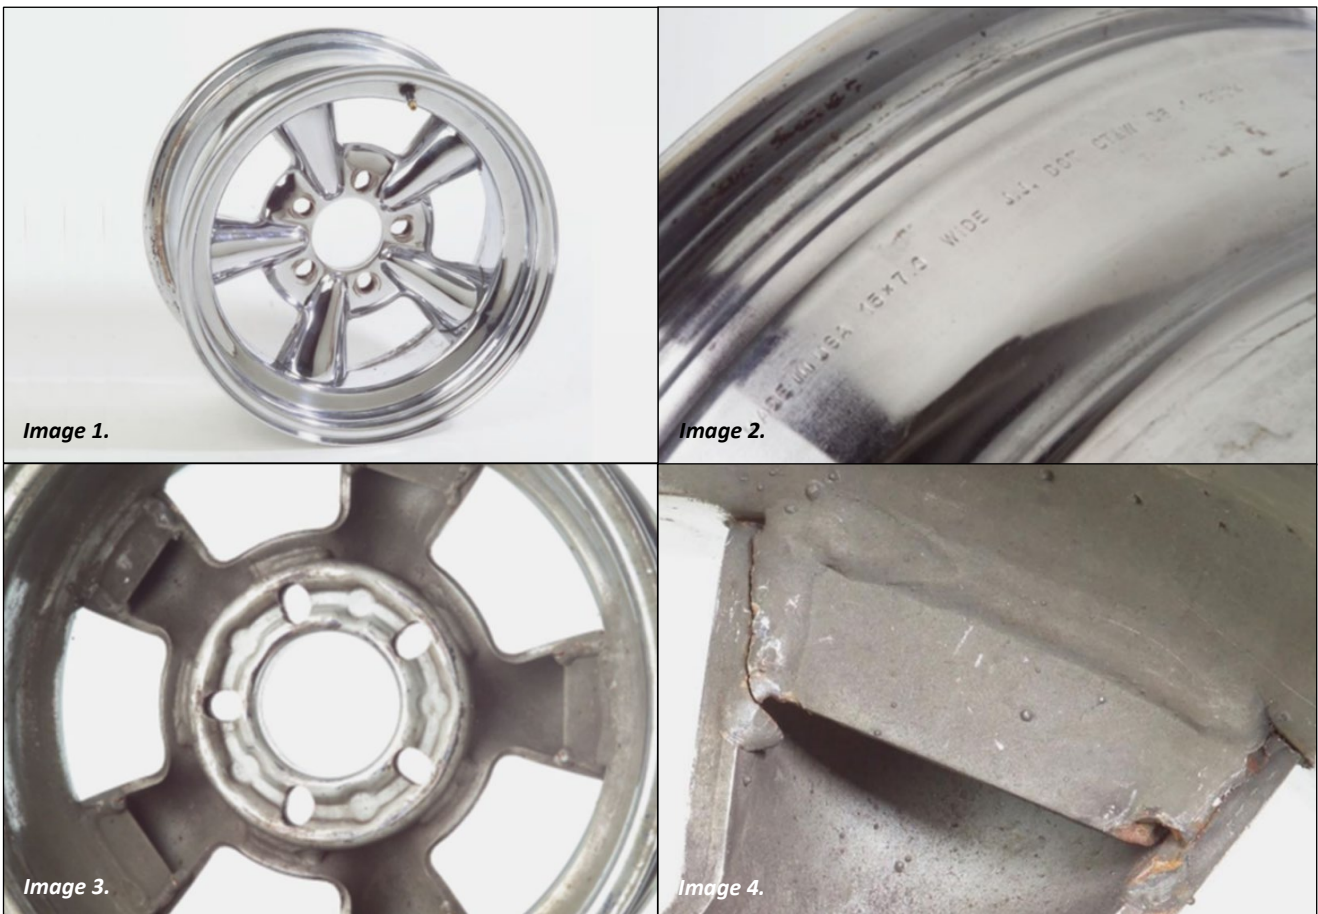
quality is very poor and prone to fatigue cracking, eventually completely separating. If such a wheel isn't cracked yet, it probably will eventually. All such wheels are at risk of complete failure.

The weld-lugs will be clearly visible with the wheel removed from the vehicle, to which, in turn, the separate centre section of the wheel is welded. Upon close inspection of the wheel, it is likely that the failed welds will be evident to the naked eye.

**Image 1:** Front face of typical copy of an Astro Supreme-brand wheel.  
**Image 2:** 'DOT' compliance marking is evident on rim, but that applies only to the rim itself, not the manufactured wheel.  
**Image 3:** View of back-face of a poorly designed and assembled 'Supreme' type wheel.  
**Image 4:** Weld failures on a copy of an Astro Supreme-brand wheel.

**Any wheels that are designed and manufactured in the same way as the inferior copies of Astro Supreme-brand wheels described in this Information Sheet may not be LVV certified.** This is regardless of the vehicle's build-date, or date of purchase or fitment of the wheels. The wheels are a known safety risk, and the LVV system must not allow their continued use.

LVV certification must be refused to any vehicle fitted with these wheels, with the sole exception of the rear of trikes, provided that:

- the tare of the trike does not exceed 500 Kgs; and
- the wheels have been subjected to an appropriate method of non-destructive testing for cracking and have been found to have no defects.
