Low Volume Vehicle Technical Association (inc)

CHECKING HOOD PROTRUSION LEGALITY

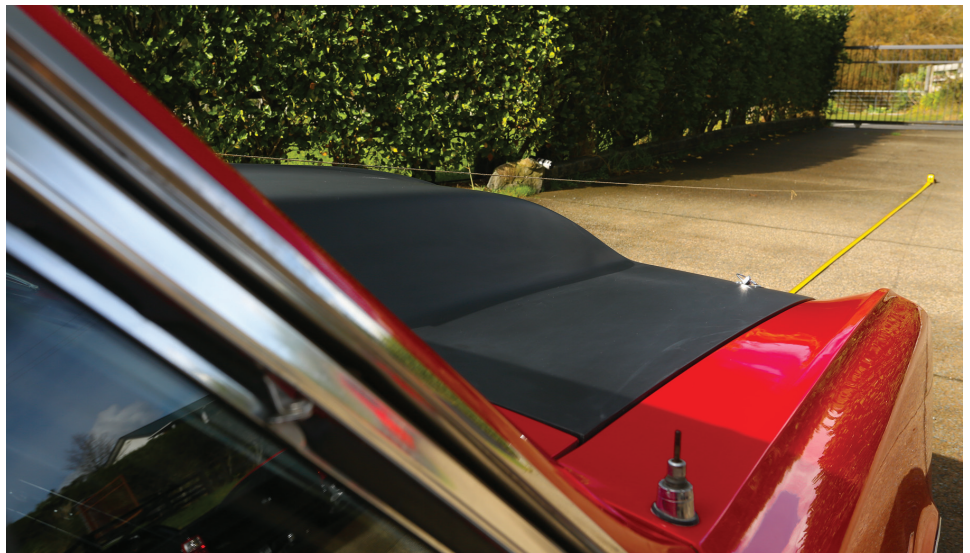
To assess this in a fixed roof vehicle, an LVV Certifier would start by finding the centre point of the windscreen. It's from this point that a string line would be taped and run forward to a point on the ground to a distance that's dependent on the width of the protrusion/s – as outlined below.

The protrusion may not extend above the string line when viewed from the side of the vehicle.

The LVV External Projections Standard states the distances the string line should extend to are:

(a) in the case of protrusions 250 mm or less in width, a point at ground level 15 metres forward of the front of the vehicle;

or
(b) in the case of protrusions between 250 mm and 400 mm in width, a point at ground level 12 metres forward of the front of the vehicle;

or
(c) in the case of protrusions 400 mm or more in width, a point at ground level 8 metres forward of the front of the vehicle
