Watch for GMV Overloading

Utes, Vans and Campers

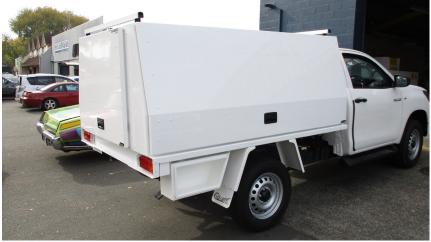
WoF inspectors are advised to keep an eye out for vehicles which may exceed their GVM and ensure that tyres are rated for the possible load carrying capacity.
