## MTA REPAIRER SECTOR

Low Volume Vehicle Technical Association (inc)

## CHECKING HOOD PROTRUSION LEGALITY

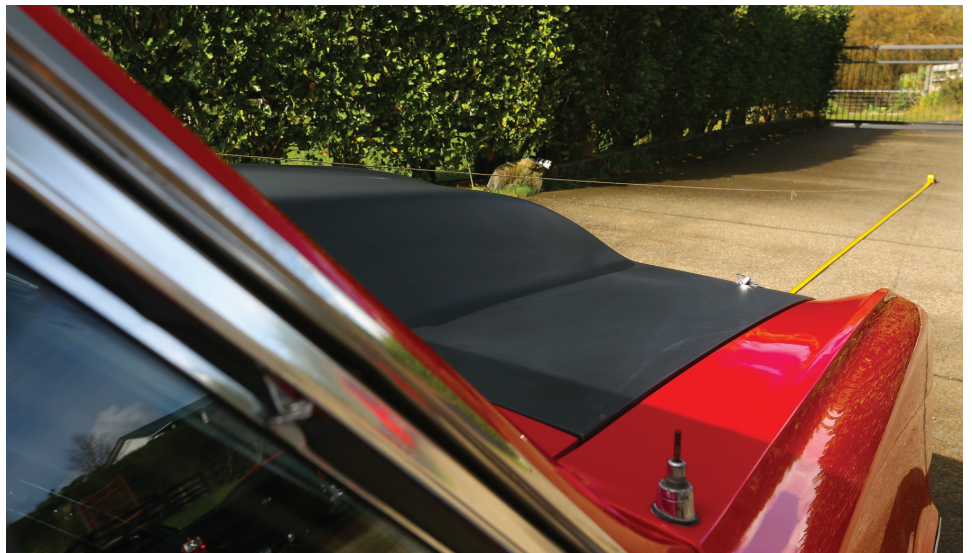
To assess this in a fixed roof vehicle, an LVV Certifier would start by finding the centre point of the windscreen. It's from this point that a string line would be taped and run forward to a point on the ground to a distance that's dependent on the width of the protrusion/s – as outlined below. The protrusion may not extend above the string line when viewed from the side of the vehicle.

The LVV External Projections Standard states the distances the string line should extend to are:

- (a) in the case of protrusions 250 mm or less in width, a point at ground level 15 metres forward of the front of the vehicle;*
- or*
- (b) in the case of protrusions between 250 mm and 400 mm in width, a point at ground level 12 metres forward of the front of the vehicle;*
- or*
- (c) in the case of protrusions 400 mm or more in width, a point at ground level 8 metres forward of the front of the vehicle*
